## STAR ONLINE PUBLICATION

**Case Number:** S2108000121

**Symptom/Vehicle Issue:** Check Engine Light On And Service Hybrid System Displayed. P0A0A-00 High Voltage System Interlock Circuit "A" Is Active

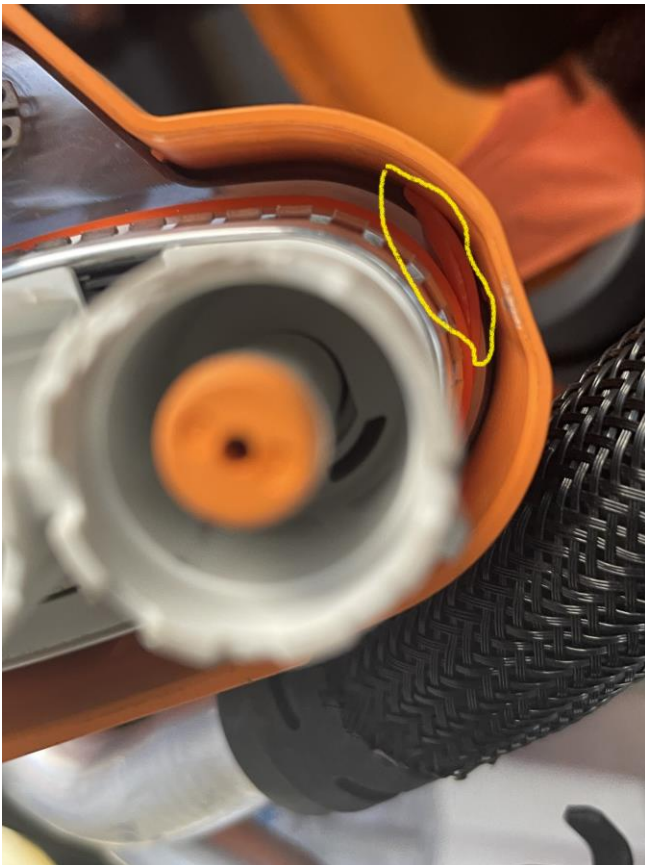
**Damaged HV Connector Seal**

Inspect the HVIL connector seals for damage or tears and the terminals for spread contacts. If any of the High Voltage connectors seals are damaged, the wiring harness will need to be replaced. If HVIL terminals appear to be spread or damaged, HV component replacement will be necessary. Contact STAR for assistance.

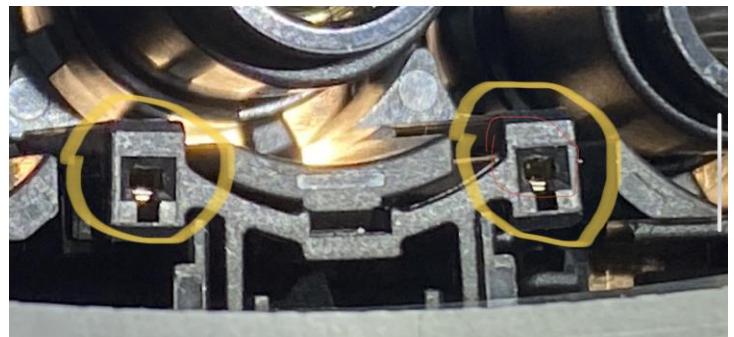
**Spread HVIL Terminals**
