**NUMBER:** 08-109-21

**GROUP:** 08 - Electrical

3.6L Check Engine Light and Rough Running Engine

2021 (DT) RAM 1500 Pickup

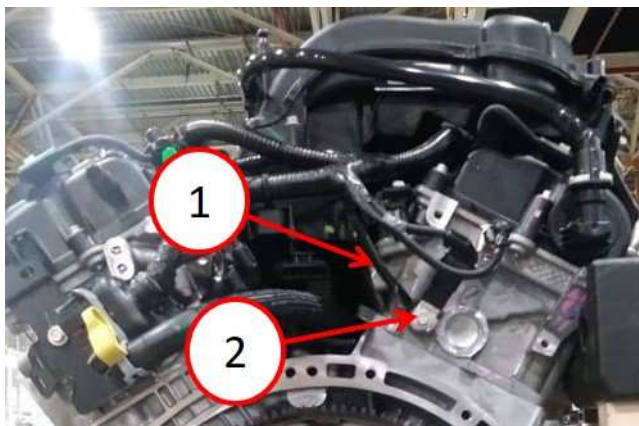
**Fig. 1**  
**Engine Ground Wiring Harness And Eyelet Bolt**

- 1 - Engine Ground Wiring Harness To Cut
- 2 - Engine Ground Eyelet Bolt

5. Using a wire cutting tool, cut engine ground eyelet from engine ground wiring harness ([Fig. 1](#)) .

11. Using Tesa tape, wrap seven wires to engine ground wiring harness.
12. Install the ground eyelet and ground bolt on engine (Fig. 1) . Tighten ground bolt to 20 N·m (15 ft. lbs.).
13. Install the lower intake manifold. Refer to the detailed service procedures available in DealerCONNECT/Service Library under: 09 - Engine, 3.6L / Manifolds / Manifold, Intake / Installation.
14. Install the upper intake manifold. Refer to the detailed service procedures available in DealerCONNECT/Service Library under: 09 - Engine, 3.6L / Manifolds / Manifold, Intake / Installation.
