**NUMBER:** 08-111-21

3.6L Check Engine Light and Rough Running Engine

This bulletin involves cutting off a wiring harness eyelet and splicing in a pigtail to the engine ground harness.

| 2021 | (JL) | Jeep Wrangler |

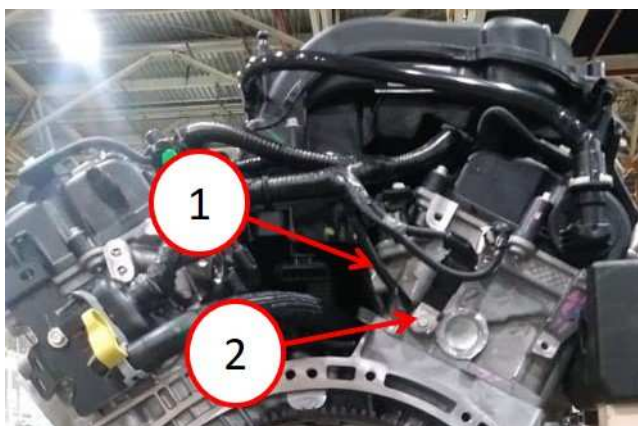
**Fig. 1**  
**Engine Ground Wiring Harness And Eyelet Bolt**

- 1 - Engine Ground Wiring Harness To Cut  
2 - Engine Ground Eyelet Bolt

1. Open the hood.
2. Remove the upper intake manifold. Refer to the detailed service procedures available in DealerCONNECT/Service Library under: 09 - Engine, 3.6L / Manifolds / Manifold, Intake / Removal.
3. Remove the lower intake manifold. Refer to the detailed service procedures available in DealerCONNECT/Service Library under: 09 - Engine, 3.6L / Manifolds / Manifold, Intake / Removal.
4. Remove the right ground bolt (**G927A**) and engine ground eyelet ([Fig. 1](#)) from engine.

5. Using a wire cutting tool, cut engine ground eyelet from engine ground wiring harness ([Fig. 1](#)) .

11. Using Tesa tape, wrap seven wires to engine ground wiring harness.
12. Install the ground eyelet and ground bolt on engine (Fig. 1) . Tighten ground bolt to 20 N·m (15 ft. lbs.).
13. Install the lower intake manifold. Refer to the detailed service procedures available in DealerCONNECT/Service Library under: 09 - Engine, 3.6L / Manifolds / Manifold, Intake / Installation.
14. Install the upper intake manifold. Refer to the detailed service procedures available in DealerCONNECT/Service Library under: 09 - Engine, 3.6L / Manifolds / Manifold, Intake / Installation.
15. Close the hood.
16. Clear any DTCs that may have been set.
