## STAR ONLINE PUBLICATION

**Case Number:** S2208000135

**Symptom/Vehicle Issue:** Malfunction Indicator Lamp (MIL) On, Diagnostic Trouble Code (DTC) P0480 Cooling Fan 1 Control Circuit Open

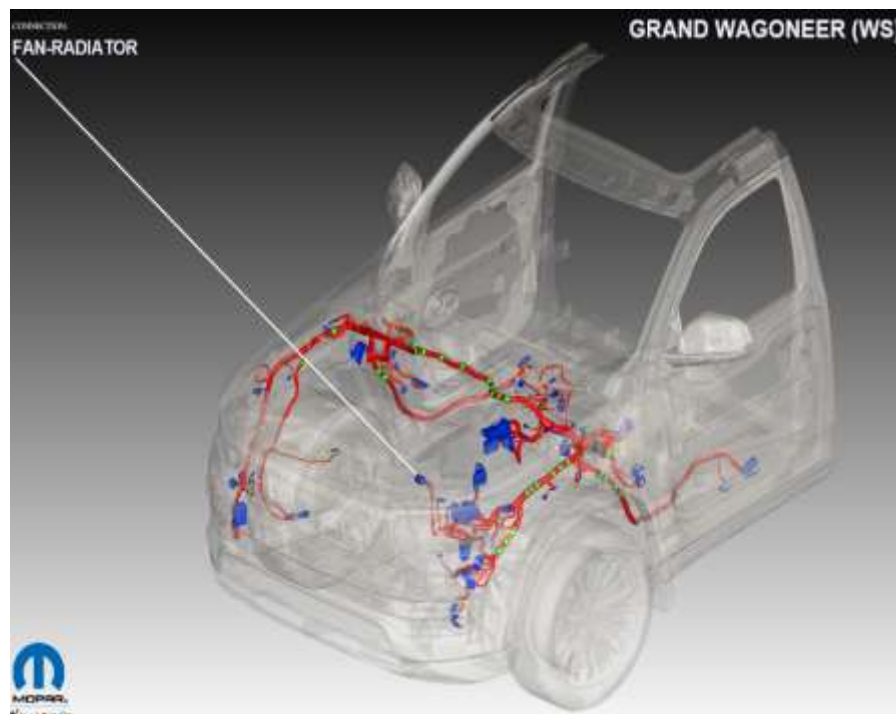
**Fig 1**

**Customer Complaint/Technician Observation:** Owner complains the MIL indicator lamp is illuminated. Technician observed the Powertrain Control Module (PCM) DTC P0480 - Cooling Fan 1 Control Circuit Open as stored or active.

**Repair Procedure:** Inspect the radiator cooling fan connector for any signs of a Terminal Pushed Out (TPO) conditions and secure all terminals. Test the involved circuits for power, ground and Pulse Width Modulation (PWM) control circuit from the PCM as needed, no parts required Fig 1, 2.
