| 22MY Tundra/HV - MIL ON w/DTC(s) P017400, P043000 - Debris In Bank 2 Fuel Delivery Pipe | | USA |
| 22MY Tundra/HV | | |

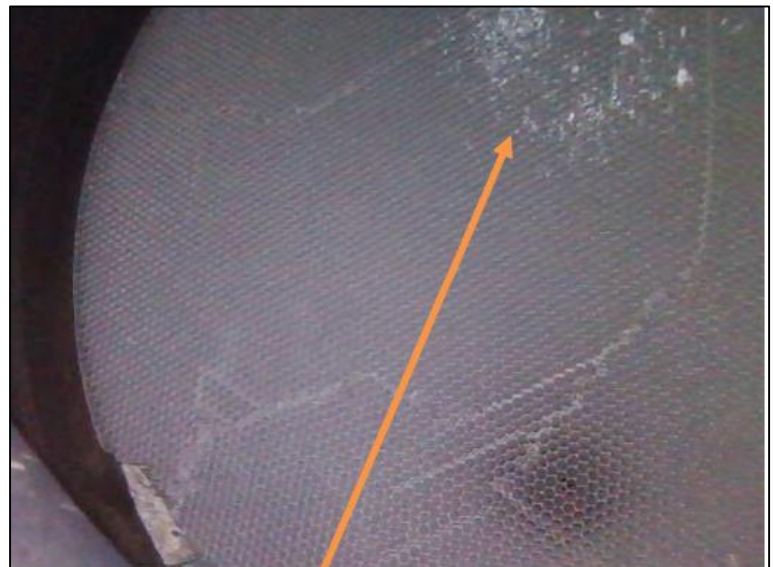
Some 22MY Tundra/HV vehicles may experience a MIL ON w/DTC(s) P017400, P043000. Other symptoms of this issue include poor acceleration. A lean condition may cause damage to the internal catalyst in the catalytic converter. See pictures below for condition:

Damage to bank 2 catalytic converter.

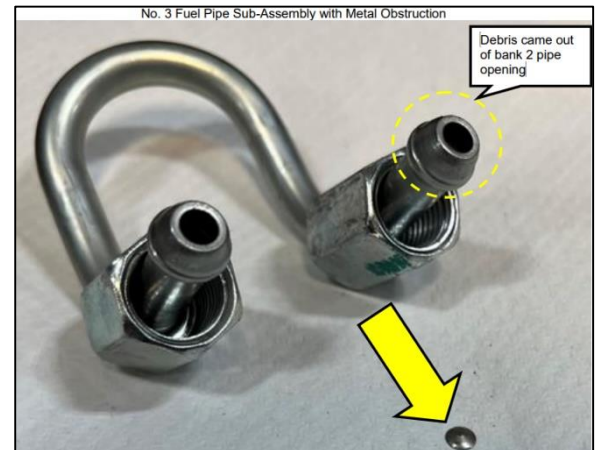
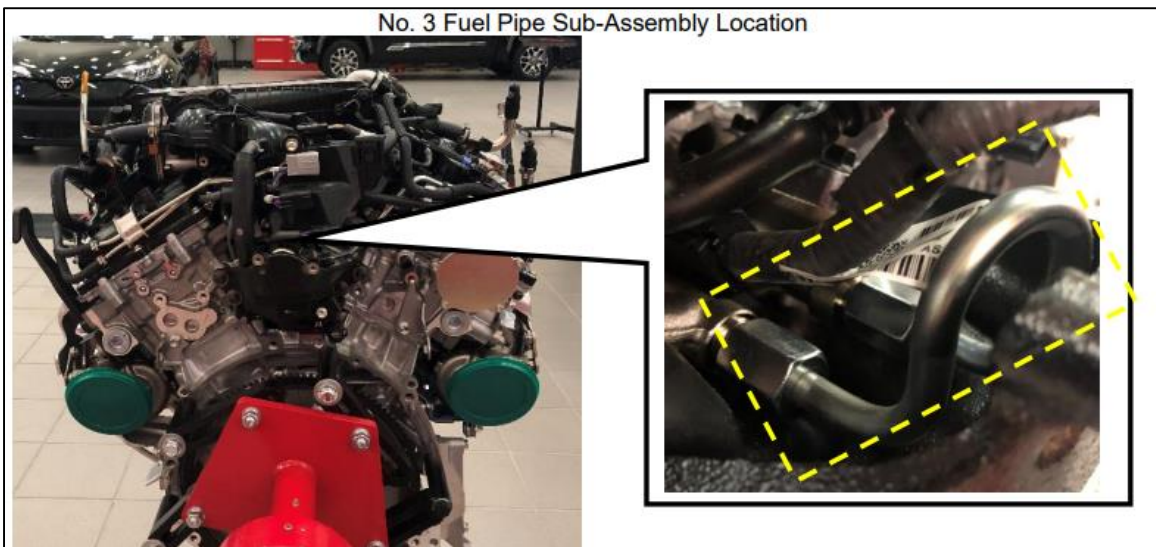
If this condition is identified, it is recommended to disassemble the No.3 fuel pipe sub assembly to inspect for obstruction and debris in the bank 2 high pressure fuel rail. Debris in the fuel rail can cause fuel blockage leading to a lean condition and poor acceleration. See below for details:

If this condition is identified, it is important to check for debris in the LH No.2 Fuel Delivery Pipe and No.3 Fuel Pipe Sub Assy connection port to help eliminate any repeat repairs for customers. Please create a TAS case and contact TAS for instruction prior to diagnosing or repairing of the vehicle. Please save all parts and/or details and submit a field report.
