# Service Bulletin

Bulletin No.: 20-NA-047

**Subject:** Front or Rear Crankshaft Oil Leak, Malfunction Indicator Lamp (MIL) Illuminated - DTC P1101 Set

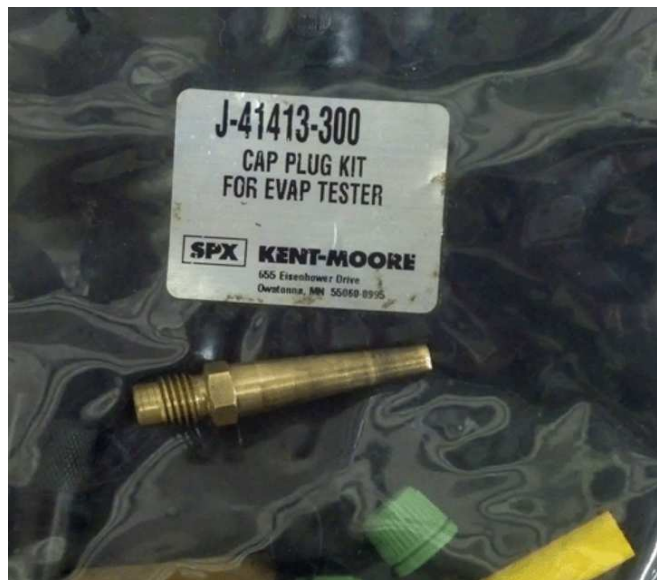
3416804

### EEST hose adaptor

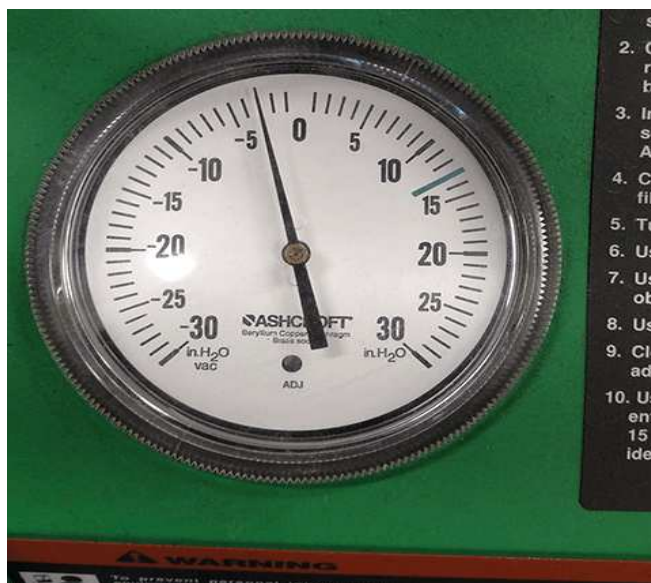
4573243

Normal crankcase pressure readings for the L3A, LE2, LFV and LYX are between -1 & -5 inches of water in park at hot idle.

- " If the crankcase pressure is in the proper range, follow Strategy Based Diagnostics for engine oil leaks and/or P1101 per SI.
- " If the crankcase pressure is excessively positive, above 0 inches of water (0 inches of HG / vacuum), then a positive crankcase pressure concern exists requiring further diagnostics.

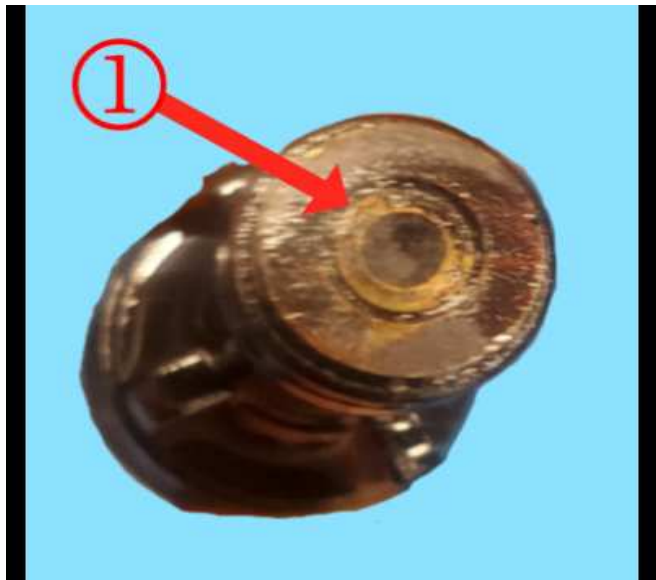
5513764

If diagnosing for oil leaks and/or DTC P1101 with no engine oil leaks and excessive positive crankcase pressure exists, an obstructed PCV orifice (1) would be suspect requiring a PCV orifice replacement.
