# Technical product information

| Topic | Engine overheating - Warning on the DIP - V8 Kovomo |
| Transaction No. | 2061369/5 |

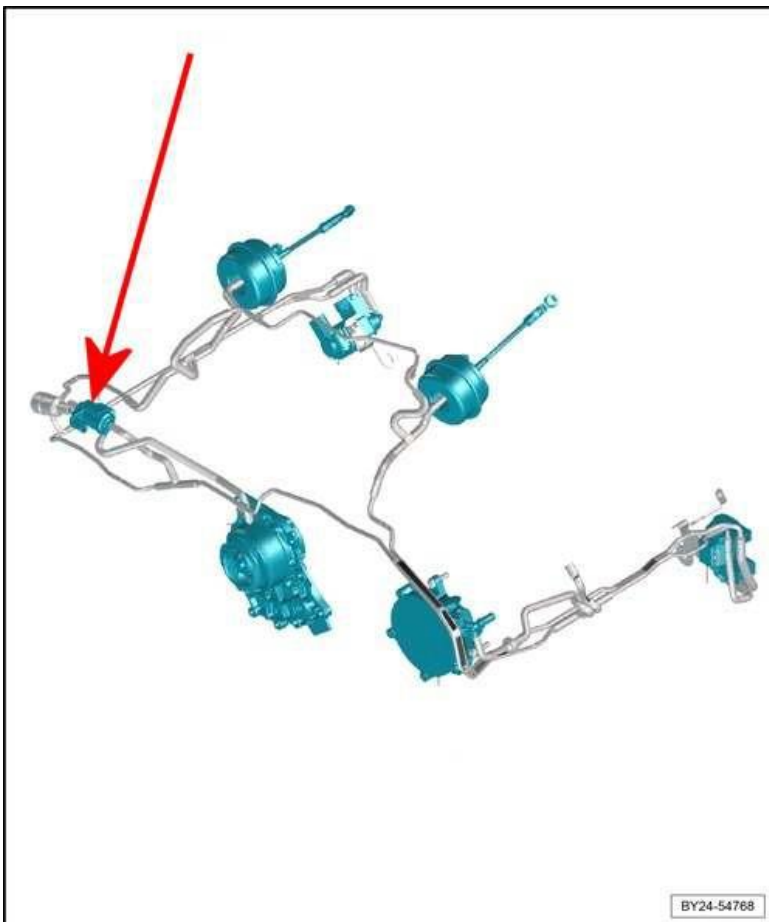
Figure 1 Shows Bentayga (Arrow)

- The switch valve for mechanical coolant pump N649 is designed to cut off the vacuum supply to the coolant pump when the engine reaches maximum temperature, the vacuum cut off allows the engine to start circulating coolant by retracting a sleeve which is situated around the coolant pump impeller

**TIP: When the switch valve for mechanical coolant pump N649 is at fault (sticking open) the vacuum supply is constant, this allows the sleeve to stay in position around the impellor which leads to the symptoms described within the Customer statement/Workshop findings section of this TPI**

**IMPORTANT:** The switch valve for mechanical coolant pump N649 fails due to an internal leak from coolant pump causing corrosion within the unit from coolant migration

1) Referring to Figures 1,2 and 3 - With care (visually monitor for any traces of coolant) disconnect each vacuum hose from the switch valve for mechanical coolant pump N649

2) Referring to Rep.Gr 19 - Replace all of the following parts

- Coolant pump
- Coolant regulator (Thermostat)
- Switch valve for mechanical coolant pump N649

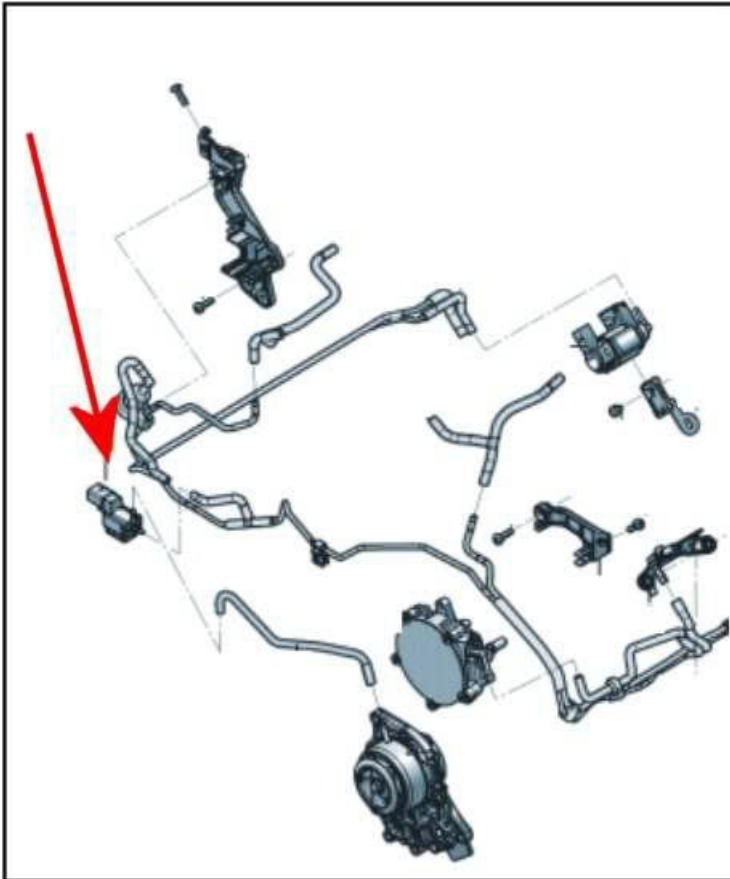
Figure 2 Shows New Continental GT/ GTC and Flying Spur (Arrow)

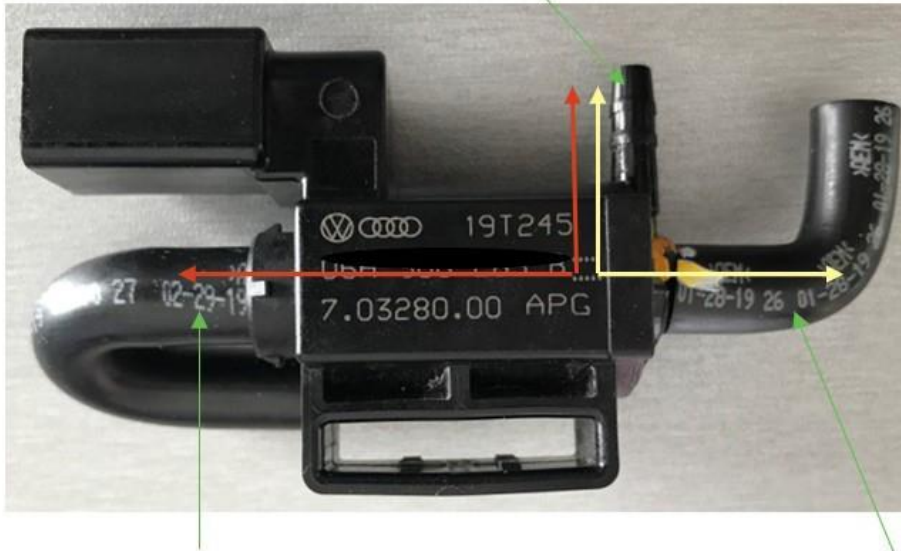
- Referring to Figure 3 the standard operation of N649 (with no operational issues) is as follows:
- Un-energised state (Ignition off) = coolant pump connected to vent connection (red arrows)
- Energised state (Ignition on) = engine vacuum connection to coolant pump (yellow arrows)

**HINT:** Figure 3 shows an example of N649 for photographic and reference purposes only
