# Technical product information

| Topic | DTC U112100 is evident following the replacement of the steering column combination switch (J527) |
| Brand | Bentley |
| Transaction No. | 2069202/1 |

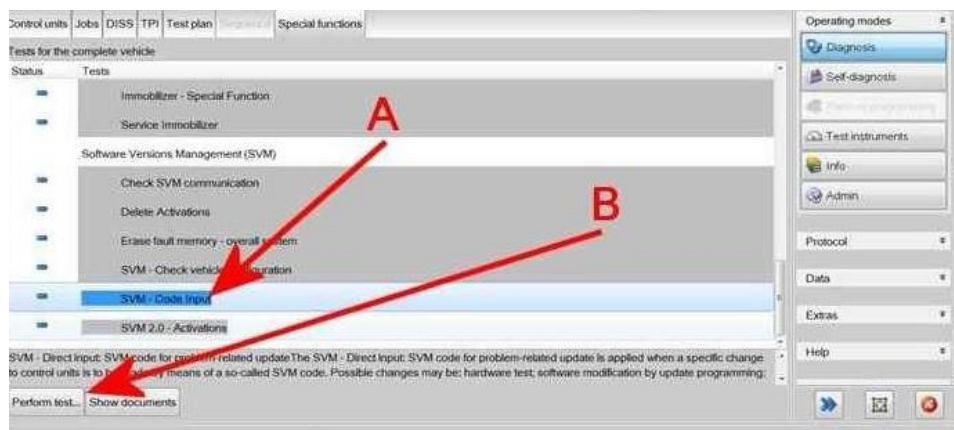
The steering column combination switch (J527) has been replaced and DTC U112100 is evident and cannot be cleared

- Referring to Figure 1 - Within the Special functions tab select SVM - Code Input (A) then select Perform test (B)
