# Technical product information

| Topic | Warnings within the DIP for the rear steering system - DTC B200096 and/or P060700 evident within diagnostic address 00CB |
| Transaction No. | 2069252/1 |

## Bentayga EWB - New Flying Spur and New Continental GT Speed

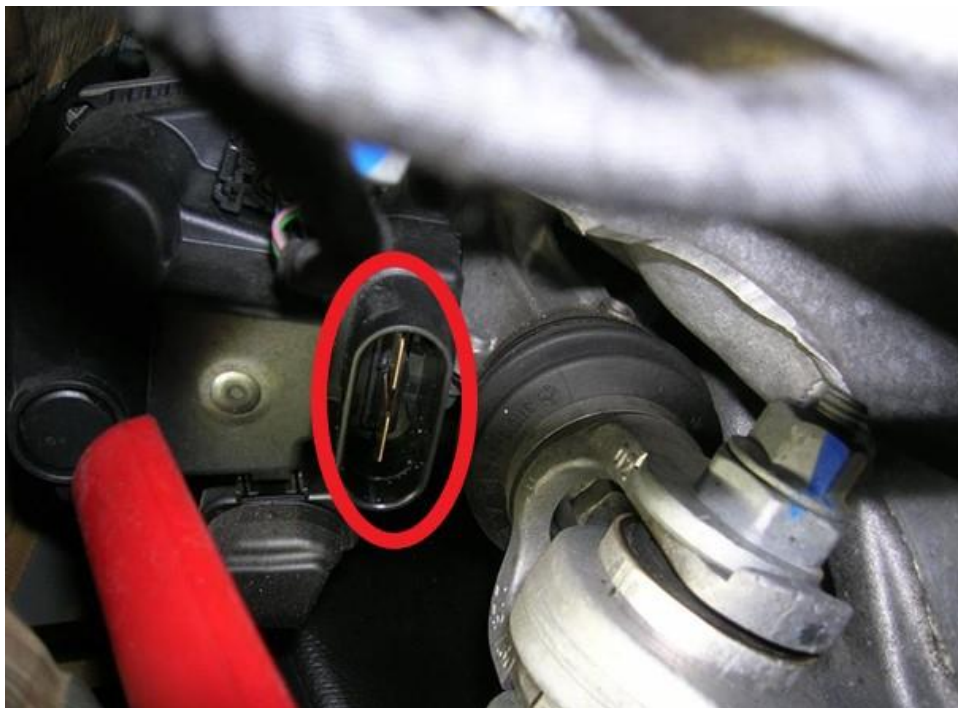
Figure 1

2) Referring to the applicable wiring diagram, conduct an electrical integrity check for the rear wheel steering control unit /J1019 (rear steering rack) in particular the 2-way 12V plug and connector (see the example shown in Figure 1) for any signs of corrosion or water damage

- Refer to the applicable wiring diagram - Check all applicable earth points of J1019 for Cleanliness, security and integrity - Rectify as applicable and retest to confirm if the DTC's are still evident
- If no faults were identified after conducting the wiring integrity checks the operative should confirm no faults were found and attach a current ODIS log to a new or existing DISS query
- The operative must await feedback from the new or existing DISS query before conducting any further work
