# Technical Service Bulletin

**94 "Electrical system fault" is displayed in the instrument cluster, DTC: P18F100, P0A1B00, U140500**  
94 23 61 2068617/2 January 17, 2023. Supersedes Technical Service Bulletin Group 94 number 22-60 dated November 18, 2022, for reasons listed below.

| Model(s) | Year | VIN Range | Vehicle-Specific Equipment |
|---|---|---|---|
| Q4 e-tron, and<br>Q4 Sportback e-tron | 2022 | All | Not Applicable |

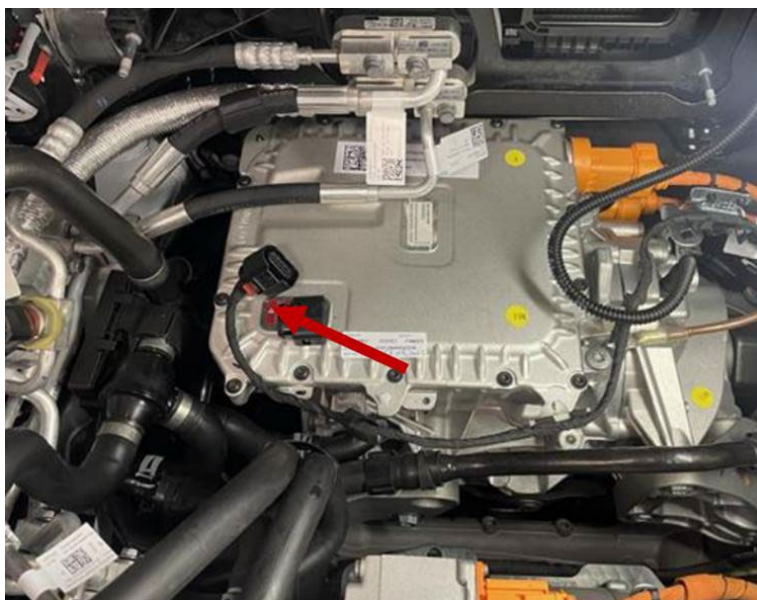
**Figure 1:** 10 Pin connector.

Pins may have become damaged during the end-of-line check during production.

Inspect connector T10 at power electronics 2 for electric drive JX4 for spread or damaged contacts:

If any damage is found to the pins or connector, replace the 10-pin connector and associated wires/pins.

**Note:** **DO NOT** de-pin the connector. Cut the connector off the harness leaving approximately 5cm of the harness attached to the connector. Retain the connector and harness section for analysis.

Replace the connector and repair the harness using **VAS 1978B**.
