# Technical Service Bulletin

**97 MIL on: DTC U064100 or U064000 for fuel tank breather - 2.0 ltr. TFSI EA888**

97 23 90 2069123/1 January 17, 2023.

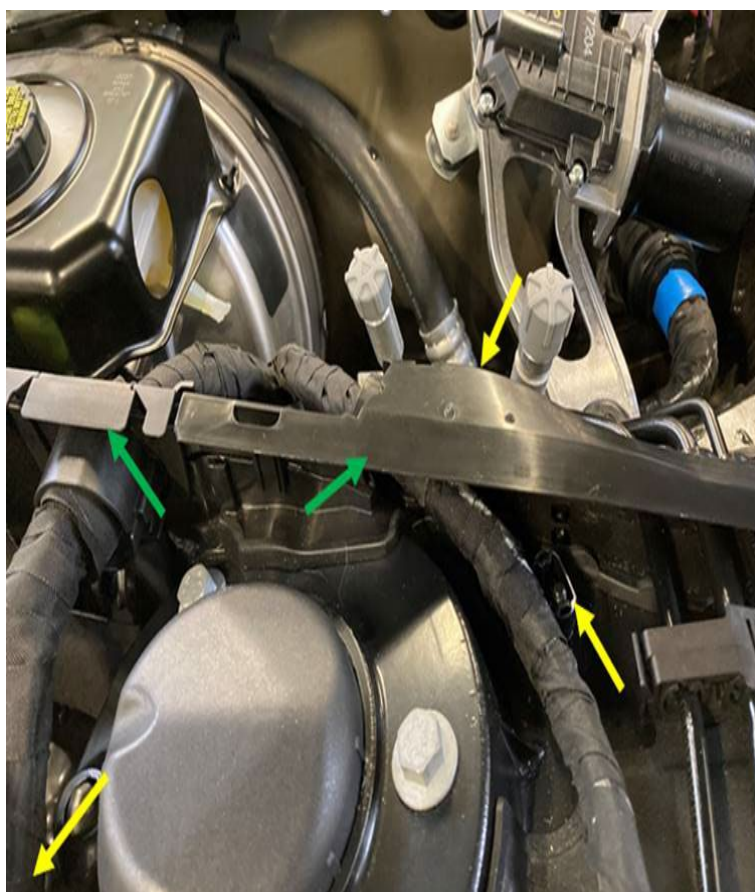
**Figure 1:** Plenum chamber covers (green arrows).

1. Remove plenum chamber covers (green arrows, Figure 1)

Release wiring harness securing clips (yellow arrows, Figure 1).

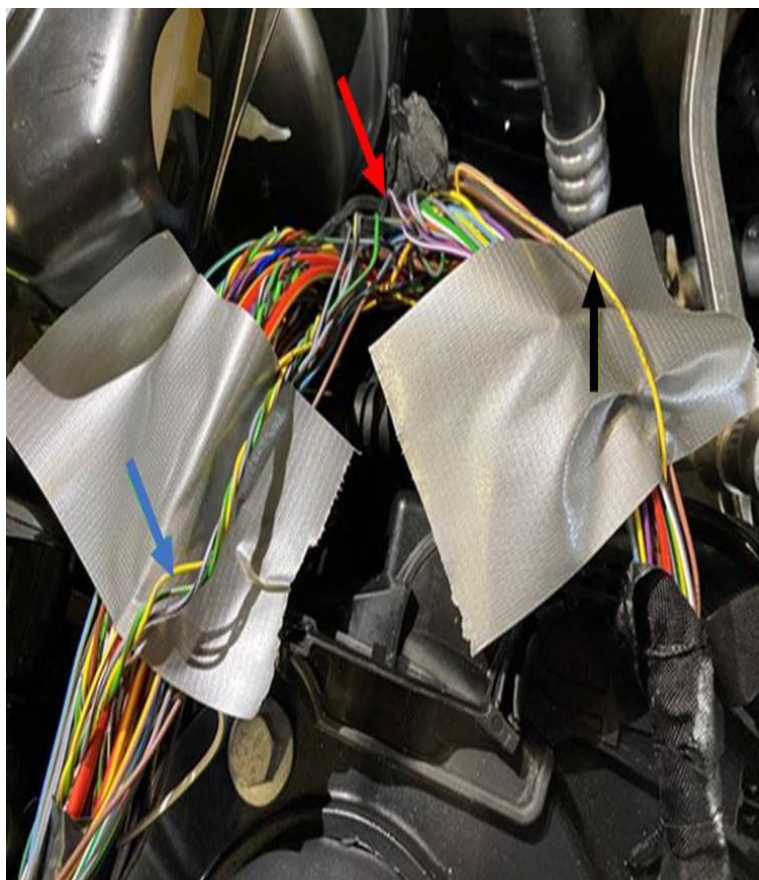
**Figure 2:** Wires isolated for modification.

2. Isolate the yellow/grey wire (triple twisted wire; blue arrow, figure 2) in the left bundle.

Isolate the yellow/purple wire in the right bundle (black arrow, Figure 2).

Cut the yellow/grey wire at the blue arrow and unravel it in the direction of the plenum chamber up to the red arrow.

Cut the yellow/purple wire at the black arrow.

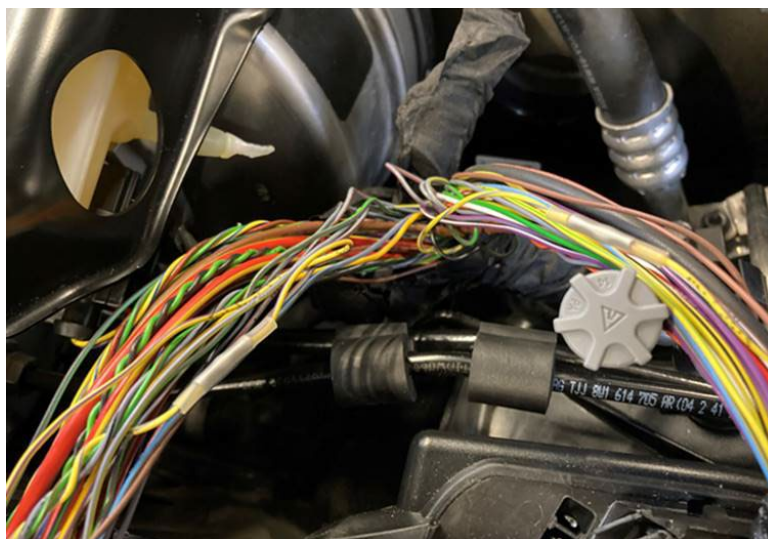
**Figure 3:** wire modification complete.

3. Using wire harness repair set **VAS 1978 B**, perform the following:

Connect the untwisted yellow/grey wire (plenum chamber side) from the left bundle to the yellow/purple wire in the right bundle (engine side).

Connect the remaining yellow/purple wire (plenum side) to the yellow/grey wire (engine side).
