# Technical Service Bulletin

**DRIVER AND/OR PASSENGER SEAT WARMER(S) ARE  
INOPERATIVE OR CANNOT BE TURNED OFF AND DTC B1520:49  
MAY BE STORED**

**Bulletin No.: 09-002/23**

2023 CX-50 (with front seat warmer and without driver-side memory power seat) and (produced before December 2022)

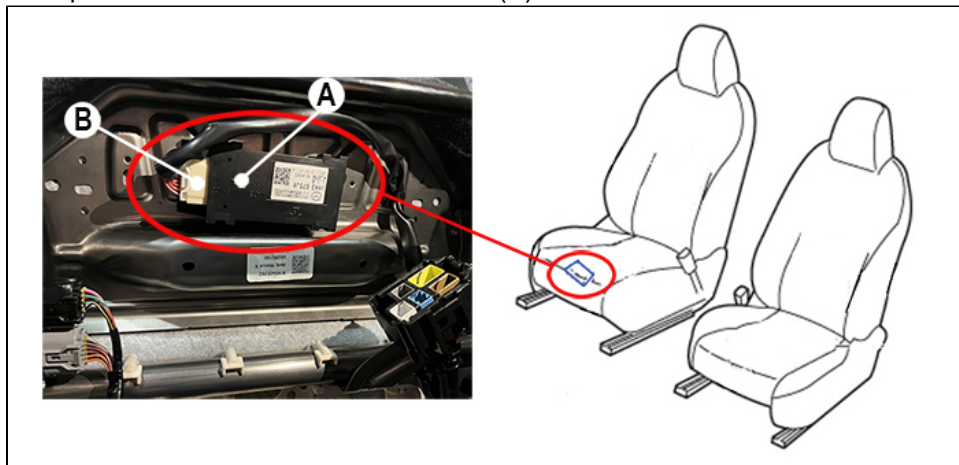
Some customers may complain that the front seat warmers are inoperative or cannot be turned OFF and DTC B1520:49 may be stored. This may be caused by an electrical noise of the front seat warmer control unit. To correct this issue, the anti-electric noise performance of the front seat warmer control unit has been improved.

1. Verify the customer concern.
2. Replace the seat warmer control unit located on the front passenger seat according to the instructions in MGSS ([FRONT SEAT REMOVAL/INSTALLATION](#)).
3. Disconnect the Seat Warmer Control Unit connector [0913-101 \(B\)](#).
4. Replace the Seat Warmer Control Unit (A).

5. Install in the reverse order of removal. See MGSS ([FRONT SEAT REMOVAL/INSTALLATION](#)).
6. Verify the repair.
