# Technical Service Bulletin

## 34 Function restriction with event memory entry P071800 - P276800 (symptom 20736 - 20737)

34 23 62 2067653/3 January 26, 2023. Supersedes Technical Service Bulletin Group 34 number 22-60 dated November 2, 2022, for reasons listed below.

| Model(s) | Year | VIN Range | Vehicle-Specific Equipment |
|---|---|---|---|
| A4, and Q5 | 2020 – 2022 | All | Not Applicable |

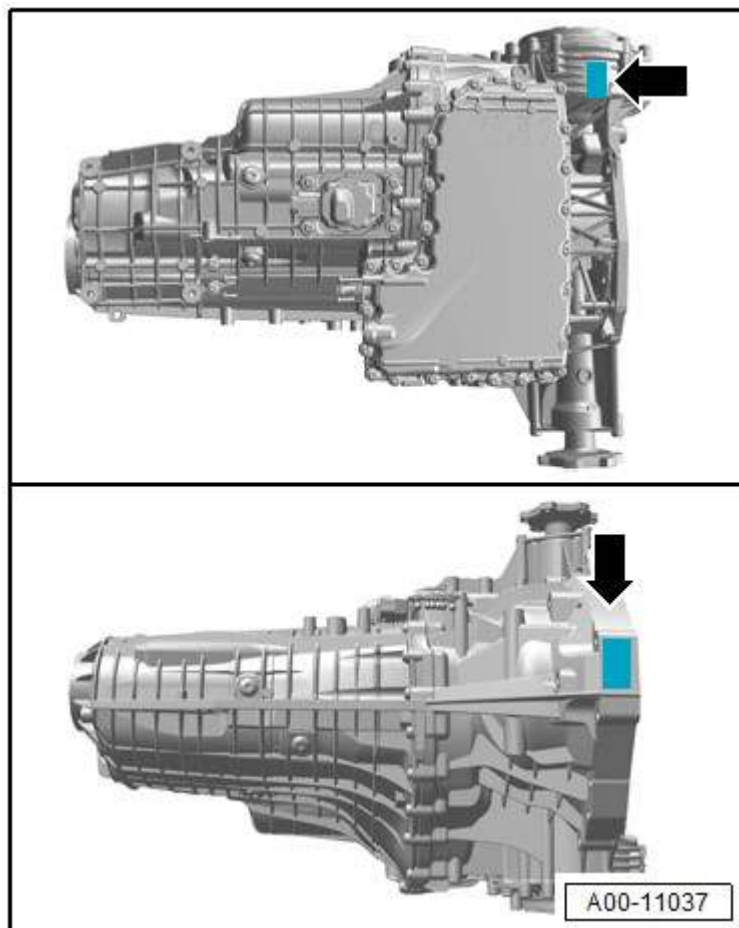
- **First determine if the Transmission was built within the date range of June 15, 2020, and May 31, 2022.**
- Check one of the transmission data stamps which are located on the bottom of the front differential and the top of the bell housing (Figure1).

**Figure 1.** Locations of data stampings.
