# Technical Service Bulletin

## 87 Air conditioning does not cool - P053000, P251500 stored in C5

87 23 38 2068460/2 January 31, 2023. Supersedes Technical Service Bulletin Group 87 number 22-35 dated November 9, 2022, for reasons listed below.

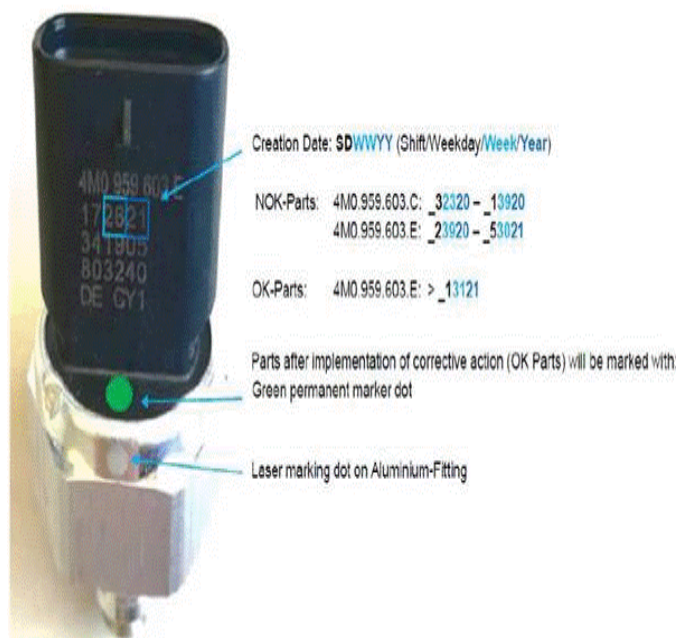
A failure of the sensor electronics causes a loss of pressure evaluation. The sensor with base part number 4M0959603 and a build date before the date Calendar Week 31, 2021 is at issue (G395 / G827).

2. Inspect the markings on the sensor to determine if the sensor has been previously replaced with an improved sensor produced after Calendar Week 31, 2021. Figure 1 shows the locations of the markings and their interpretation. In this example, while the sensor is an 'E' index sensor, contains a green dot on the connector housing and a laser marking on the aluminum housing the build date of the sensor is *before* Calendar Week 31, 2021, and would require replacement.

**Figure 1.** Pressure and temperature sensor markings and build date.

1. Should the vehicle present with the symptom profile described in this TSB inspect and/or replace all of the pressure sensors in the refrigerant circuit that are of the base part number 4M0959603 and have a build date before Calendar Week 31, 2021. Each model for which this TSB appears will have between 1 and 3 of this type of sensor installed at various positions in the refrigerant circuit, either on the low or high pressure sides of the circuit (G395 / G827).

3. A sensor with index 'E', produced after Calendar Week 31, 2021, has a green dot on the connector housing, and has a laser marking on the aluminum housing is of the improved type and need not be replaced.
