# TECHNICAL SERVICE BULLETIN

AN22-007A

ITB22-017A

## DTC B2E01-96 (INTERNAL BATTERY) STORED AS CURRENT IN IVC

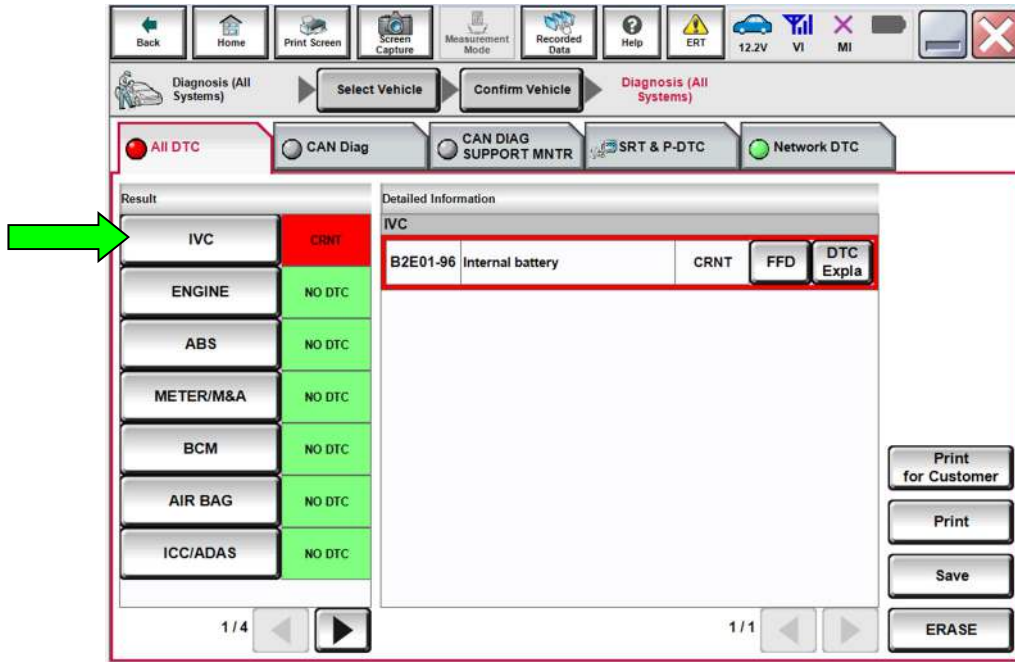
Figure 3

11. Confirm that DTC B2E01-96 for Internal battery is “CRNT” in the **IVC**.

- If only DTC B2E01-96 is present, select **IVC** (Figure 3) and then proceed to step 12.
- If additional DTCs, other than B2E01-96, are present in the **IVC**, refer to the ESM for further diagnostic information and repair first, and then proceed to step 12.
