# TECHNICAL SERVICE BULLETIN

| EC22-013 | ITB23-001 | January 18, 2023 |

## MIL ON WITH DTC P0101 AND/OR P010B STORED IN THE ECM

**APPLIED VEHICLES:** 2016-2023 Q50 (V37)  
2017-2022 Q60 (CV37)

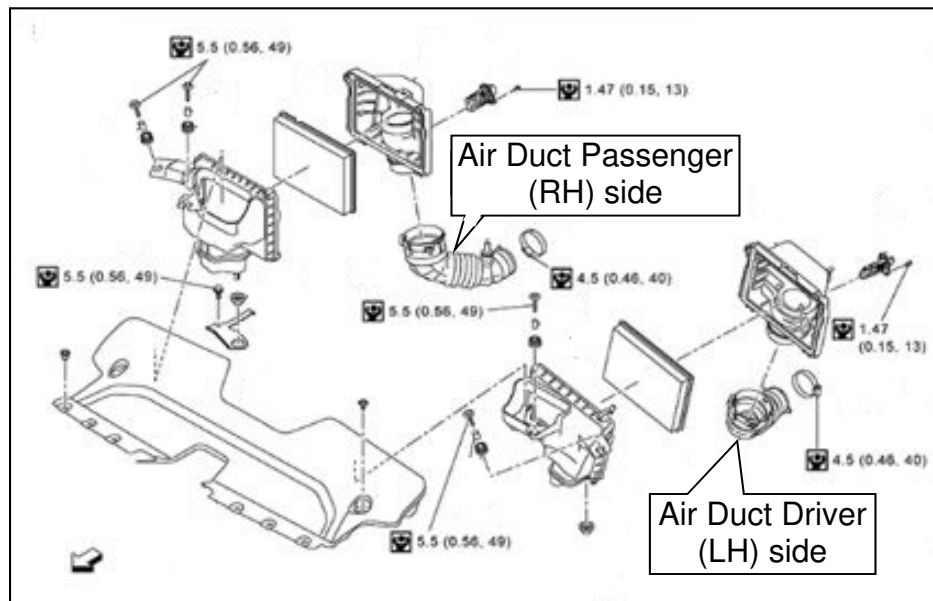
Figure 1

If the MIL is ON and DTC P0101 (MAF SEN/CIRCUIT-B1) and/or DTC P010B (MAF SEN/CIRCUIT-B2) is stored in the ECM on an **APPLIED VEHICLE**, follow the information in this bulletin along with the ESM to complete the required repairs.

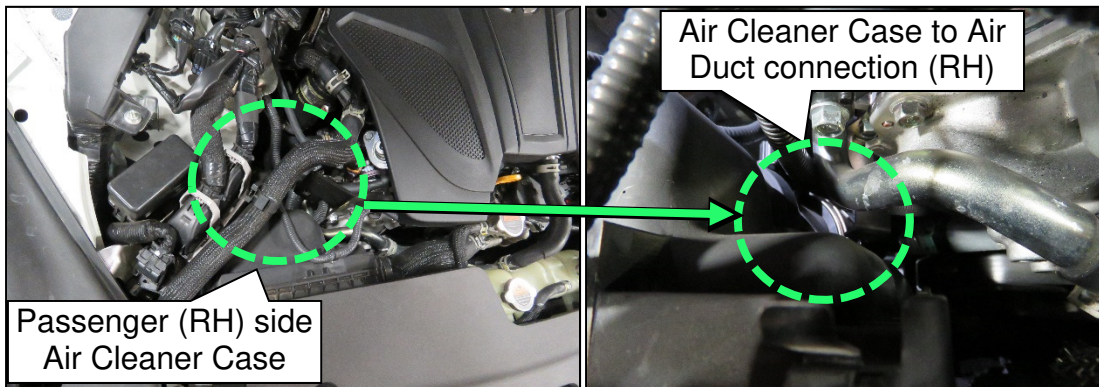
Figure 2

- Never shock the Mass Air Flow Sensor.
  - Never disassemble the Mass Air Flow Sensor.
  - Never touch the sensor of the Mass Air Flow Sensor.
1. Inspect the applicable Air Duct(s) for any leaks or poor connections.
    - For DTC P0101, inspect the passenger (RH) side Air Duct (Figure 2 and Figure 3).
    - For DTC P010B, inspect the driver (LH) side Air Duct (Figure 4 and Figure 5).

2. Disconnect/remove the Air Duct as needed, and then correctly reconnect/reinstall the Air Duct, ensuring there are no leaks.
  - For 2016-2019 models, refer to ESM: **ENGINE > ENGINE MECHANICAL > VR30DDTT > REMOVAL AND INSTALLATION > AIR CLEANER AND AIR DUCT > Removal and Installation**
  - For 2020-2023 models, refer to ESM: **REPAIR > ENGINE > ENGINE MECHANICAL > REMOVAL AND INSTALLATION > AIR CLEANER AND AIR DUCT > Removal and Installation**
