# Service Bulletin

Bulletin No.: 22-NA-113

**Subject:** Head Up Display (HUD) Blank, Non-Responsive to Brightness, Aim, or Page Controls, DTC U0158 Set

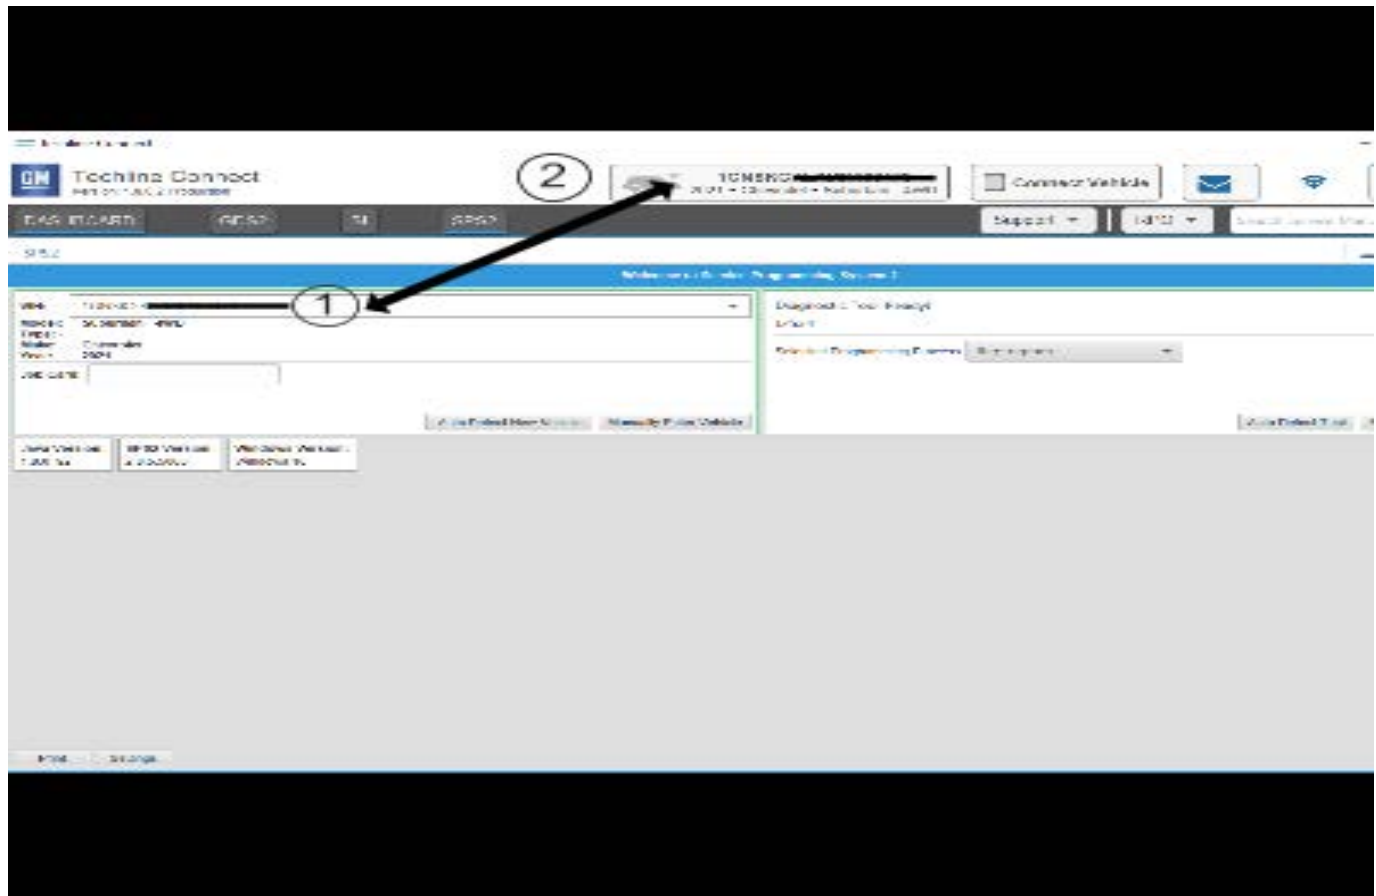
5743643

Caution: Be sure the VIN selected in the drop down menu (1) is the same as the vehicle connected (2) before beginning programming.

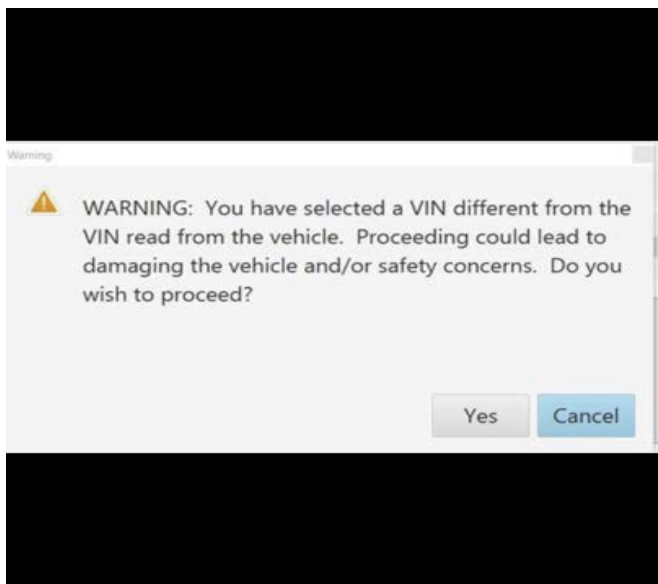
5877000

Important: If the vehicle VIN DOES NOT match, the message below will be shown.

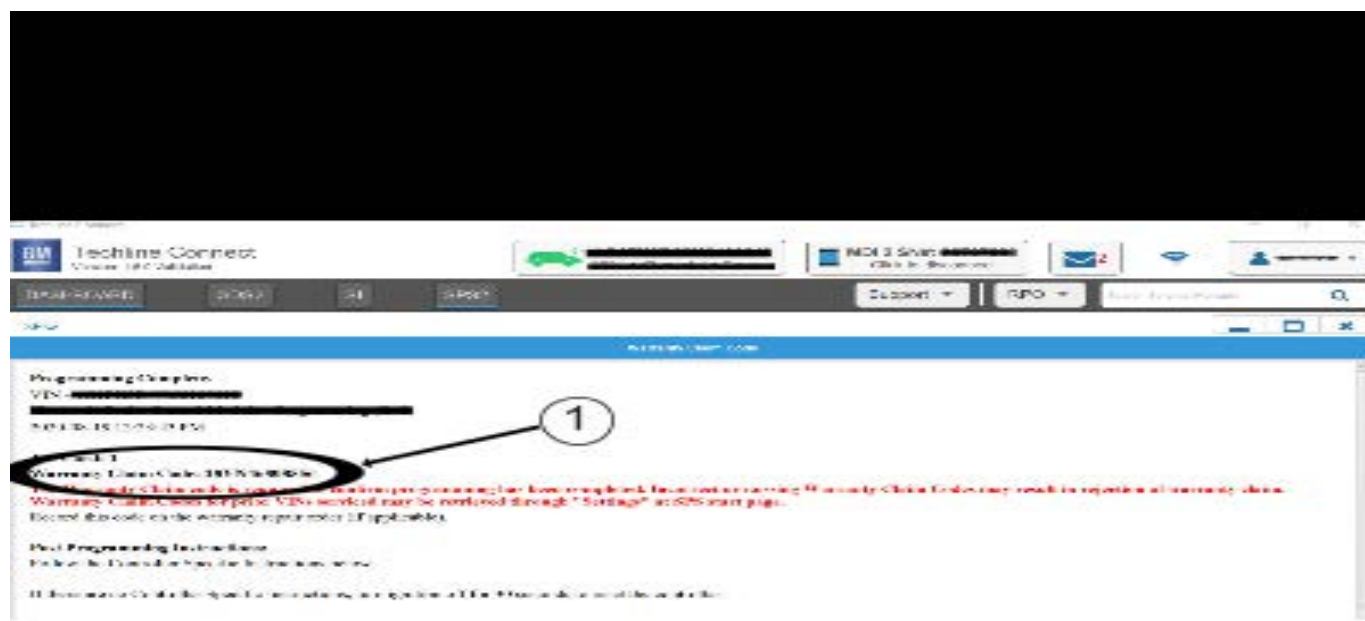
5644478

Note: The screenshot above is an example of module programming and may not be indicative of the specific module that is being programmed. Module selection and VIN information have been blacked out.

**Important:** To avoid warranty transaction rejections, you **MUST** record the warranty claim code provided on the Warranty Claim Code (WCC) screen shown above on the job card. Refer to callout 1 above for the location of the WCC on the screen.
