# TECHNICAL SERVICE BULLETIN

| DA22-004A | NTB22-073A | January 24, 2023 |

## REAR AUTOMATIC BRAKING WARNING LIGHT ILLUMINATED AND/OR DTC C1B56-04 AND/OR C1B56-97 STORED IN THE ADAS CONTROL UNIT

**APPLIED VEHICLES:** 2019-2022 Altima (L34)

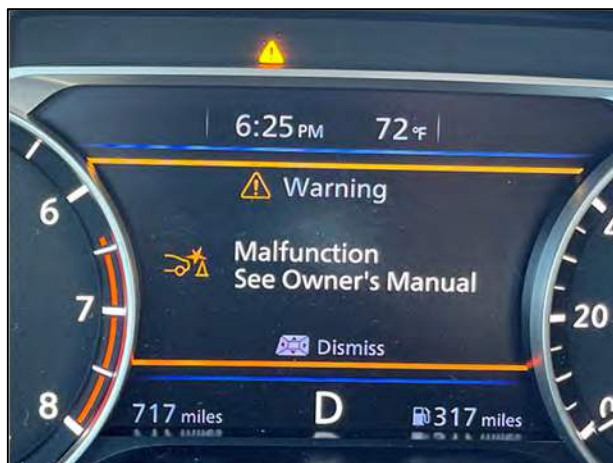
Figure 1

The customer states the rear automatic braking (RAB) warning light is illuminated, with "Malfunction See Owner's Manual" appearing in the vehicle information display,

DTC C1B56-04 (SONAR CIRCUIT) and/or C1B56-97 (SONAR CIRCUIT) is stored in the ADAS Control Unit.

Reprogram and configure the Sonar Control Unit using the **SERVICE PROCEDURE** in this bulletin, if applicable.
