# TECHNICAL SERVICE BULLETIN

| EC22-012 | NTB23-006 | January 18, 2023 |

## MIL ON WITH DTC P0101 AND/OR P010B STORED IN THE ECM

**APPLIED VEHICLES:** 2023 Z (Z34)

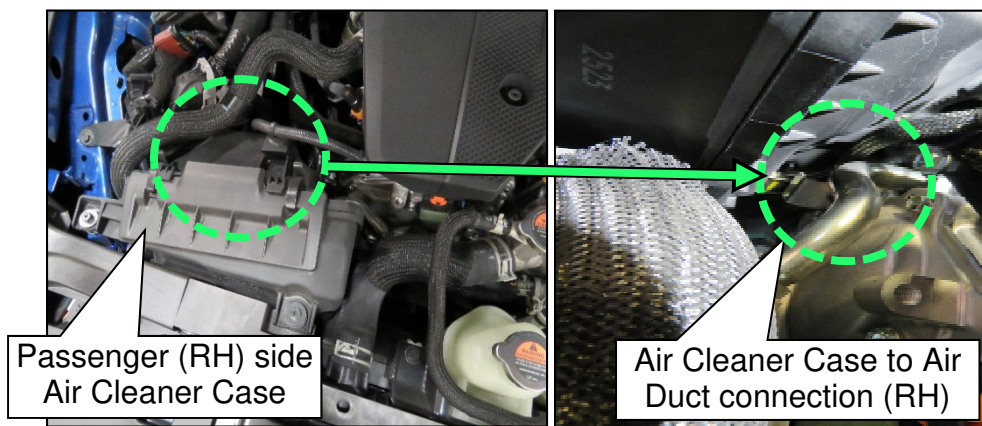
Figure 2

- Never shock the Mass Air Flow Sensor.
  - Never disassemble the Mass Air Flow Sensor.
  - Never touch the sensor of the Mass Air Flow Sensor.
1. Inspect the applicable Air Duct(s) for any leaks or poor connections.
    - For DTC P0101, inspect the passenger (RH) side Air Duct (Figure 2 and Figure 3).
    - For DTC P010B, inspect the driver (LH) side Air Duct (Figure 5 and Figure 4).

2. Disconnect/remove the Air Duct as needed, and then correctly reconnect/reinstall the Air Duct, ensuring there are no leaks.
  - Refer to ESM: **ENGINE > ENGINE MECHANICAL > REMOVAL AND INSTALLATION > AIR CLEANER AND AIR DUCT > Removal and Installation**
