## QUALITY ACTION

## CAMPAIGN BULLETIN

### Front Bumper/Headlamp Dealer Inventory

Reference: P2A21

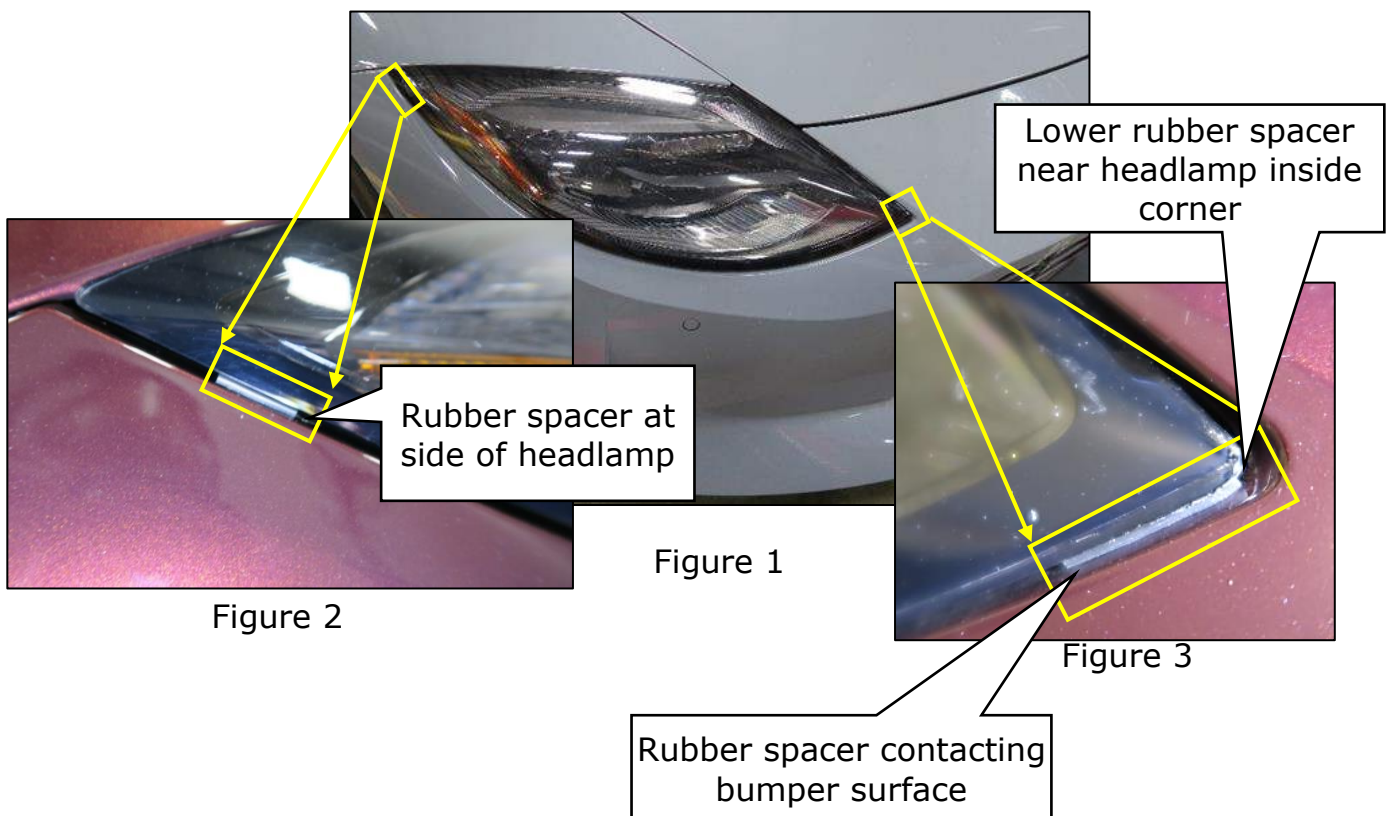
1. Inspect for the presence of the side rubber spacers and the position of the lower rubber spacers in the areas shown in Figure 1.

- The side rubber spacer should be visible between the headlamp and front bumper in the area location shown in Figure 2
- The lower rubber spacer should be positioned near the inside corner of the headlamp and **MUST** be contacting the front bumper surface as shown in Figure 3

- If Rubber spacers are present **AND** in the correct location, continue to **Step 2** for clearance check.
- If the Rubber spacers are **NOT** present **OR** are in the incorrect location, skip to **Step 3** for paint inspection, then continue to **Step 4** for spacer installation.

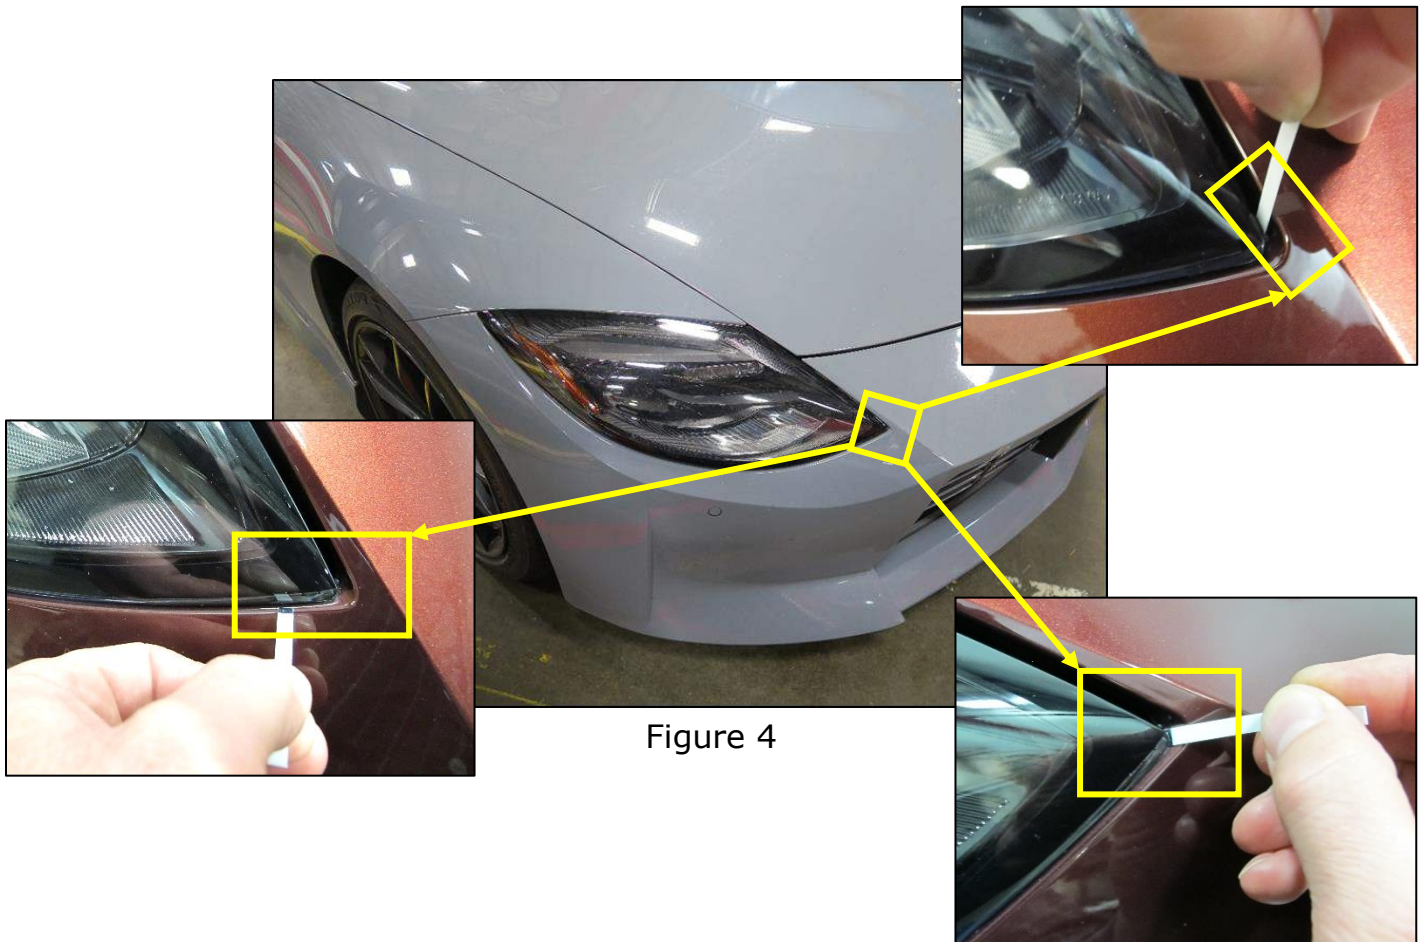
Figure 4

2. Using a 0.5mm (0.020") white plastic gap gauge from the parts kit, check the clearance between the headlamp and the front bumper in the areas shown in
- Tool should easily slide between front bumper and headlamp

In some cases the rubber spacer may prevent the gap gauge from entering between the bumper and headlamp. This condition is normal and the spacer should **NOT** be replaced for this condition.

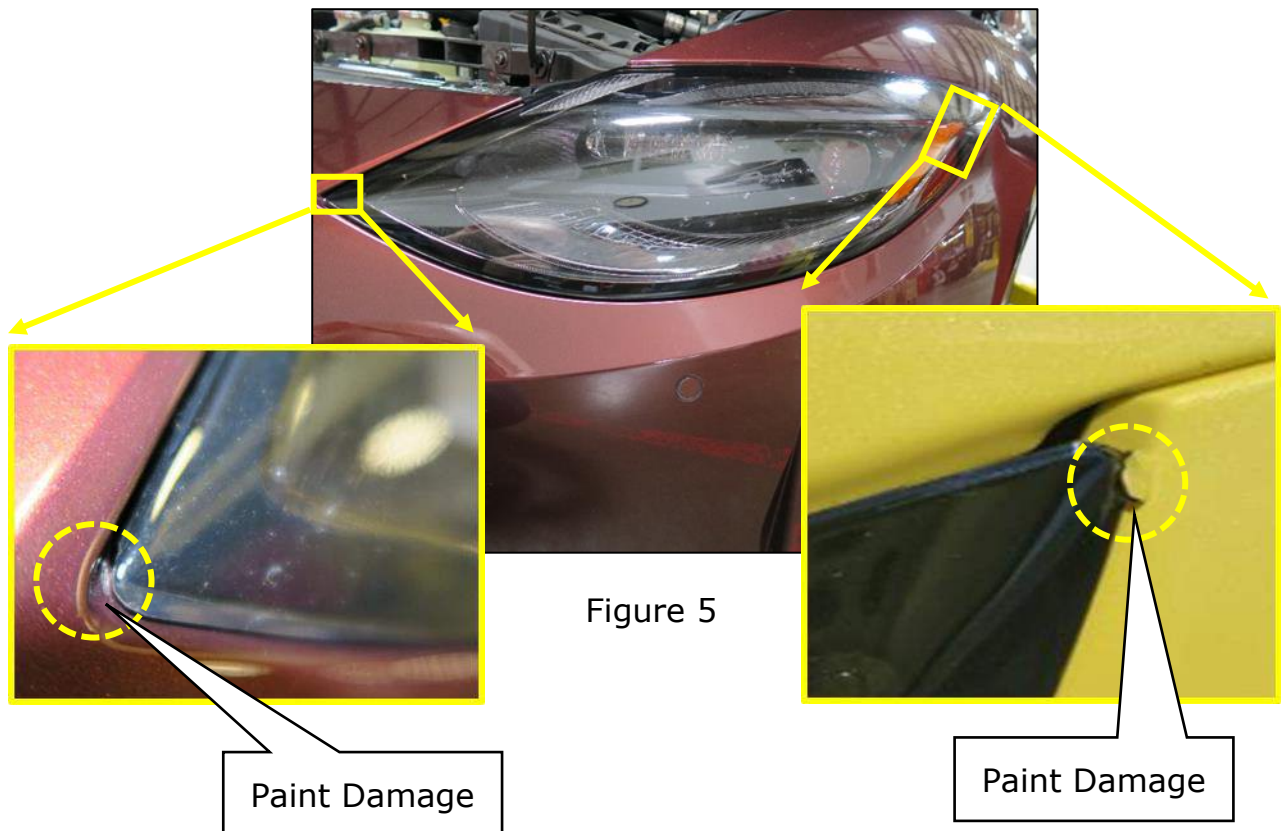
Figure 5

3. Visually inspect the corners of the front bumper for paint damage. (Examples of damage shown in Figure 5)
- If **Steps 1, 2 AND 3** inspections are **OK**, no further action is needed, the procedure is complete. Submit claim using OP Code P2A210.
  - If **ANY** of the inspections from **Steps 1-3** are found **NG**, proceed to **Step 4** for repairs.

**YES** - If the front bumper has paint damage in the area inspected in **Step 3**, perform the necessary paint repairs before continuing with **Step 24**.

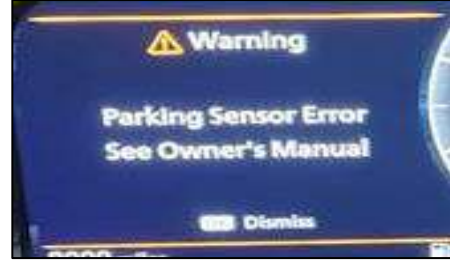
- Verify there are NO parking (sonar) sensor errors are present in the combination meter (gauge cluster)
  - If **NO** errors are present,
    - Turn the engine off
  - If an error similar to the one shown in Figure 50 is present, verify the connectors behind the RH front fender liner are connected and locked
    - If both connectors are connected and locked, remove the front bumper and locate the sonar sensor connector that is not connected or not fully seated
