## PIT5946A Check Engine Lamp With DTC: P0606 set in the Body Control Module

| Brand: | Model: | Model Years: | VIN: | | Engine: | Transmissions: |
|---|---|---|---|---|---|---|
| Chevrolet | Silverado 1500 New (RPO J22, VIN Digit 5 = A or D) | 2022 | All | All | All | All |
| GMC | Sierra 1500 New (RPO J22, VIN Digit 5= H or U) | 2022 | All | All | All | All |

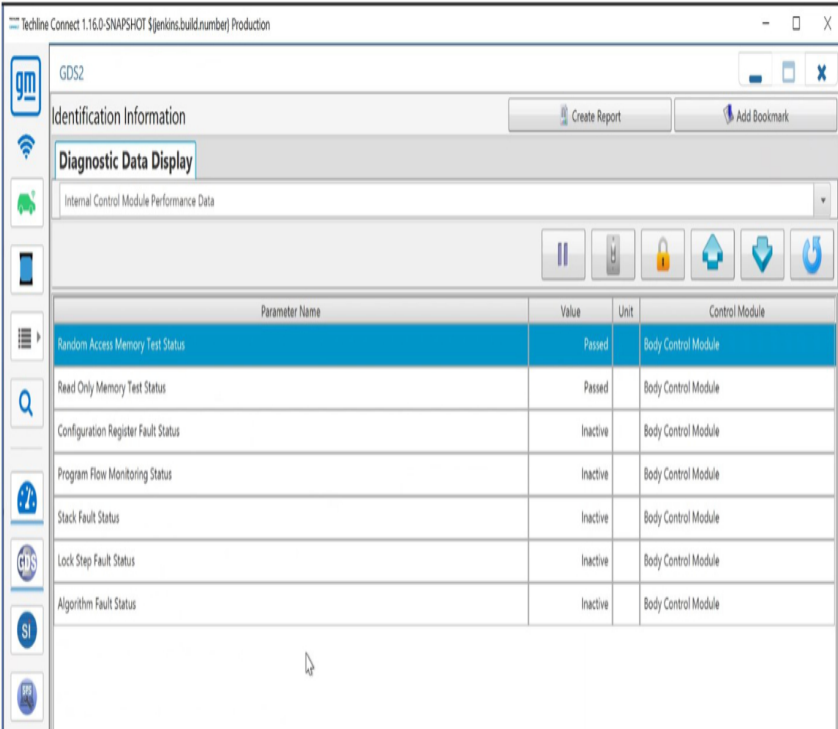
Connect an MDI2 to the vehicle and navigate to GDS2 and select the following: > Module Diagnostics > Body Control Module > Identification Information > Internal Control Module Performance Data

Review the parameters. If only the "Program Flow Monitoring Status" is active and all other parameters are inactive, please attempt to program the BCM with the latest calibration in Techline Connect under the SPS Tab.

If the BCM software is up to date or an update was just performed, review "Program Flow Monitoring Status" parameter once more.

If the “Program Flow Monitoring Status” parameter is still "Active" with all other parameters reading inactive, then clear codes and take no further action.

Do not replace the BCM to try and resolve this concern.
