# Preliminary Information

## PIP5829A MIL Illuminated With DTC P0299 and/or Cold Start Rattle Noise From the Engine Compartment

### Models

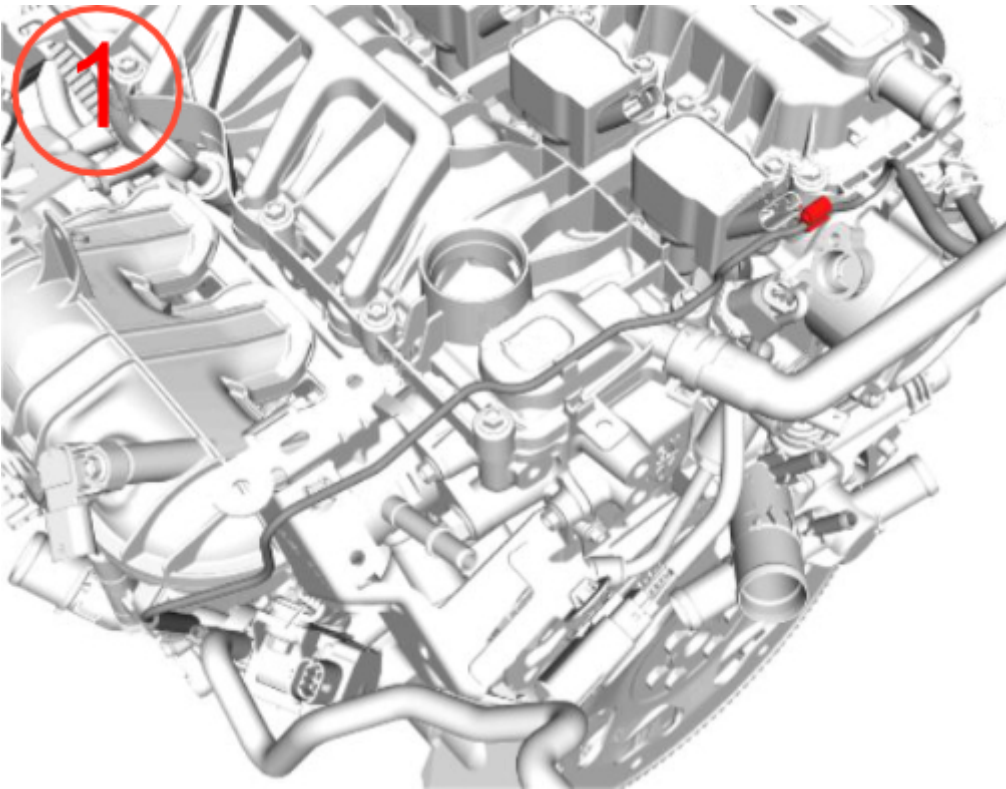
Disconnect the Turbocharger Wastegate Solenoid Vacuum Supply Hose (shown in fig 1 below) from the Turbocharger Wastegate Solenoid Valve.

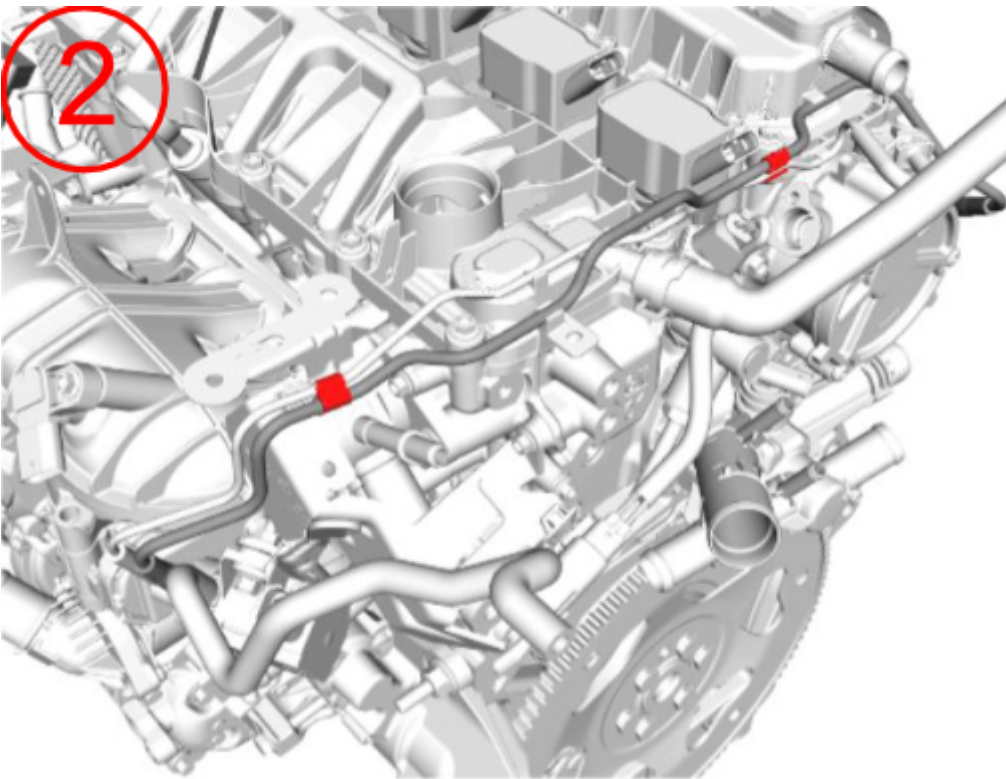
Disconnect the Turbocharger Wastegate Solenoid Actuator Supply Hose (shown in fig 2 below) from the Turbocharger Wastegate Solenoid Valve.

Connect the EN-23738-A Vacuum Pump to the Turbocharger Wastegate Solenoid Valve Actuator supply port.
