GLOBAL SAFETY FIELD INVESTIGATIONS  
DCS6449  
URGENT - DISTRIBUTE IMMEDIATELY

Subject: N232395320 - Special Coverage  
Camshaft Cover

Models: 2019 Buick Cascada

## N232395320 Camshaft Cover

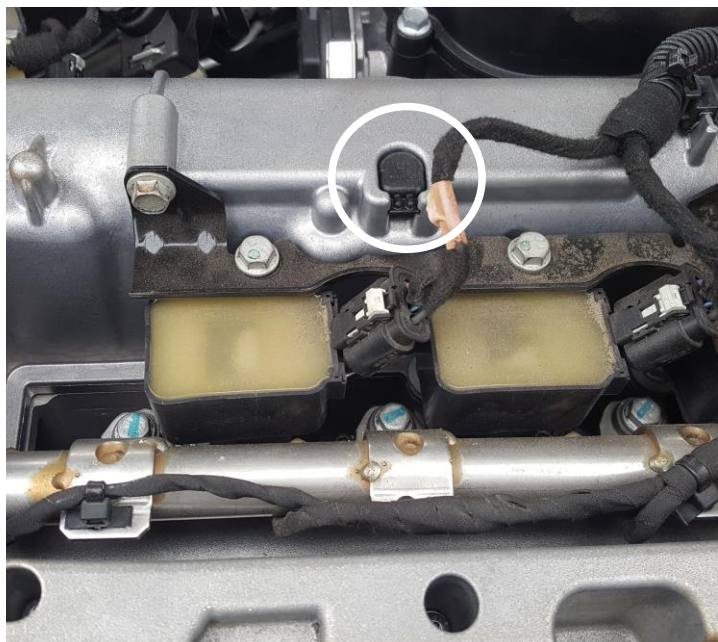
5509278

- 2.3 With the engine running, listen for noise coming from the PCV valve, shown above. If noise is heard, check to see if the noise gets quieter or disappears with the engine oil dipstick removed.

2.5 Check to see if there is vacuum at the PCV vent at the front of the PCV valve by placing a piece of tissue near it. The tissue will be sucked against the vent and held if vacuum is present.

- If the PCV valve is making noise and there is vacuum present at the PCV valve vent, replace the Camshaft Cover. Refer to *Camshaft Cover Replacement* in SI.
- If the PCV valve does NOT make noise or leak vacuum, no further diagnosis or repair is covered under this special coverage. Claim diagnostic time and inform the customer that any further diagnostics or repair will have to be covered by customer pay, warranty, or good will.
