# Technical Service Bulletin

## 01 Engine Crankcase breather Whistling Noise and DTC P227900 warning light ON

01 23 44 2069351/2 February 13, 2023. Supersedes Technical Service Bulletin Group 01 number 23-43 dated February 7, 2023, for reasons listed below.

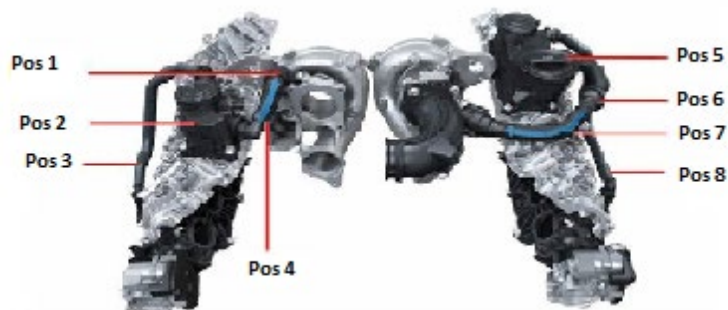
Item 1: Non-return valve

Item 2: Oil separator for bank 1

Item 3: Part load breather line

**Item 4: Full load breather line (Replacement required)**

Item 5: Oil separator for bank 2

Item 6: Non-return valve

Item 7: Full load breather line

Item 8: Part load breather line

In this case, replace the full load breather line for cylinder bank 1.

1. Do not replace the oil separator for bank 1 or bank 2 or the part load breather lines.
2. Please refer to image of the crankcase breather from the Self Study Program 920493 as a guide.
