# Technical Service Bulletin

## 91 Audi connect user management option greyed out or SOS and Roadside with no function, DTCs P169A00, U13EB00

91 23 72 2052299/7 February 10, 2023. Supersedes Technical Service Bulletin Group 91 number 23-69 dated February 6, 2023, for reasons listed below.

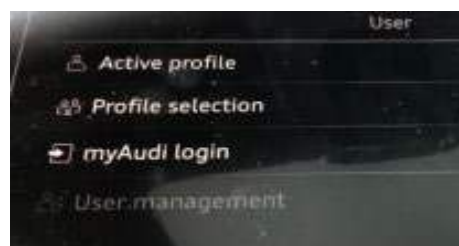
**Figure 1.** User management.

- The Audi connect “User management” screen is greyed out and the customer cannot complete the key user pairing (Figure 1).

- **DTC P169A00** (Transport mode active) is stored in the engine control module (ECM), J623 (address word 0001).
- **DTC U13EB00** (Emergency call module and communication unit Flight mode activated) is stored in the emergency call module and communication unit, J949 (address word 0075).

In order to activate the ConBox LTE data connection, the vehicle must be taken out of transport mode using the VAS 6154. The older diagnostic heads (e.g. VAS 5054 or previous) cannot properly address this control unit over diagnostics due to the new diagnostic protocol. If the VAS 6154 is not used, then the ConBox will remain in transport mode (Flight mode) and will set a DTC of P169A00 (Transport mode active). Additionally, the gateway module will set a DTC of U142100 (Control module for emergency call module and communication unit no communication).

1. Change the adaptation for flight mode in diagnostic address 0075 at, *Self-diagnosis >> Go to address 0075 >> Adaptation values "Basis connect function" >> Flight mode >> Deactivate.*
2. Hit "Apply".
3. Cycle the ignition off and then back on.
4. Within Self-diagnosis go to DTC readout for diagnostic address 0075 and clear the DTC.
5. Cycle the ignition off and then back on again.
6. Verify that the SOS light is green and/or the Audi connect User management option is now selectable.
7. If the issue persists disconnect the tester, roll the windows up, close all doors, and lock the vehicle for 2-3 minutes to allow the car to go through a sleep cycle, then retry steps 4-6 if necessary.

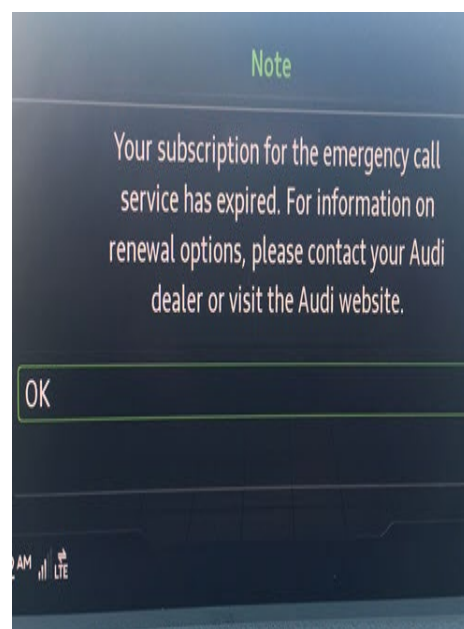
**Figure 2.** Error message in MMI.

- The SOS emergency button is red or flashing red. When the customer presses the button, the message “Your subscription for the emergency call service has expired. For information on renewal options, please contact your Audi dealer or visit the Audi website” (Figure 2) is displayed.
