# Technical Journal

**Backup Battery DTC TCAM-U210993**

| REF NO:<br><b>TJ 35602.5.0</b> | ISSUING DEPARTMENT:<br><b>Technical Service</b> | CAR MARKET:<br><b>United States and Canada</b> | |

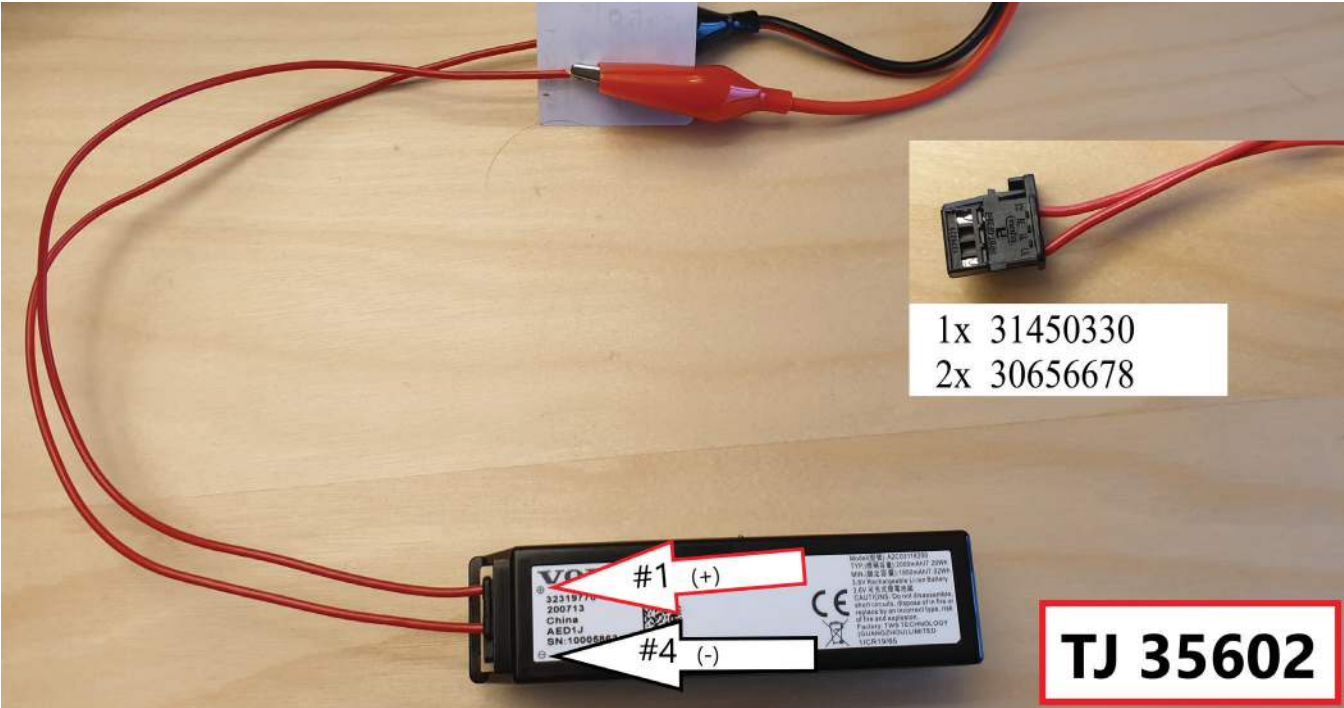
Pin 1 Positive.

Pin 4 Negative.

It is possible to charge the BUB outside the vehicle using a universal battery charger suitable for 1 cell lithium-ion battery which supplies max 4V and max 1A, the max temperature must not exceed 60°C / 140°F. (There is no suitable Volvo charger for this operation)

To make an adapter harness to connect to the BUB, you need following parts:

1x 31450330 RECEPTACLE HOUSING.  
2x 30656678 REPAIR TERMINAL.
