## Technical product information

| Topic | DTC B17B801 and/or B17B804 - evident within address 0019 and/or DTC U112300 evident in 00A5 |
| Brand | Bentley |
| Transaction No. | 2063855/6 |

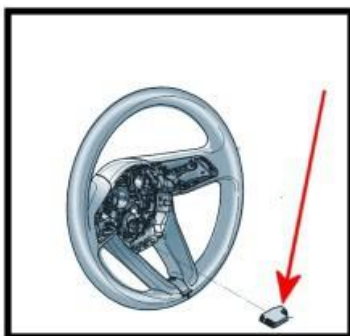
- DTC - B17B801 - Steering Wheel Touch Recognition Control Module evident within **address 0019**

- DTC B17B804 - Steering Wheel Touch Recognition Control Module electrical error - evident within **address 0019**

- DTC U112300 with symptom Code 1123220 within **address 00A5**

- 1) Referring to Rep.Gr 69 - Remove the driver's air bag
- 2) Referring to Figure 1 - Fit a new Control Unit for Steering Wheel Contact Detection control unit (J1158) to the new steering wheel
