## Technical product information

| Topic | Bentayga and New Flying Spur Hybrid– DTC P103A00 evident – Engine Oil Fuel Portion Too High |
| Brand | Bentley |
| Transaction No. | 2062365/4 |

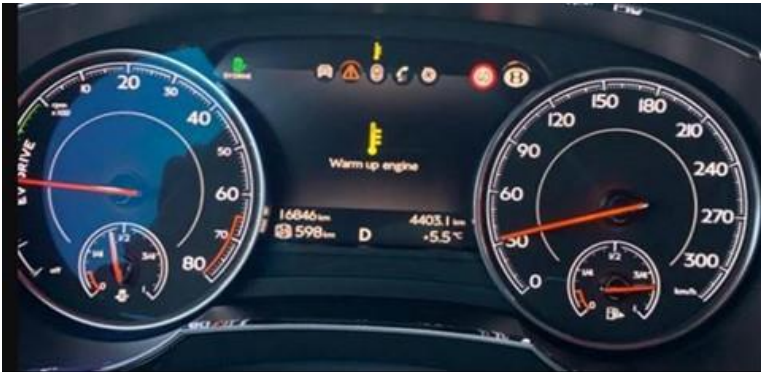
Figure 1

- Warning message within the DIP
- The message asks the customer to 'warm up engine' accompanied by a yellow warning (Figure 1) No other symptoms are experienced.

The warning is caused by the level of unburnt fuel in the engine oil. This value is calculated by the Engine Control Module (ECM) and is based on the driver usage pattern

The more cold starts the Internal Combustion Engine (ICE) is exposed to the higher the chance of fuel making its way into the engine oil via the cylinders

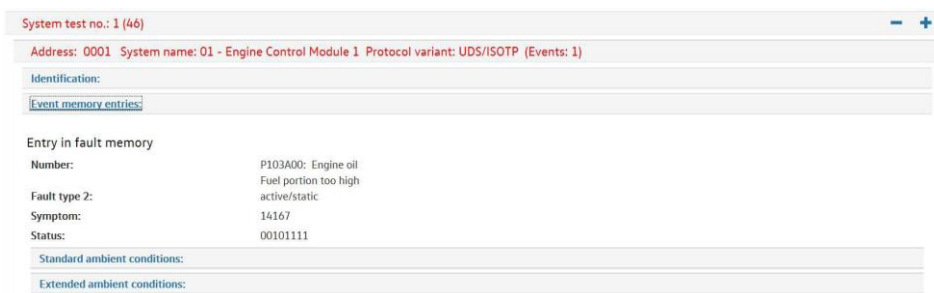
Figure 2

- DTC P103A00 evident - Engine Oil Fuel Portion Too High (Figure 2)

- Smell of fuel in the engine oil

When the fuel calculation reaches the pre-programmed amount this then causes the DTC to be triggered

2) Referring to the Rep.Gr 17- Check the engine oil level *NOTE: Ensure the method within Rep.Gr 17 is followed*

- **IMPORTANT:** In the event the engine oil level is deemed as excessively high, the oil level should be reduced/corrected - Refer to Rep.Gr 17 - Drain the required amount of engine oil to adjust the oil level to specification

3) Drive the vehicle in SPORT mode for 30 KM (**Observing all local speed limits**) with enthusiastic driving to reduce the fuel MWB value (IDE09531) to less than 50 grams

- In the event the MWB value (IDE09531) has been successfully reduced (Lower than 50 grams) Erase the applicable DTC's
