# Technical Service Bulletin

CHECK ENGINE LIGHT ON WITH DTC P0524 OR P055F

Bulletin No.: 01-004/23

Last Issued : 02/03/2023

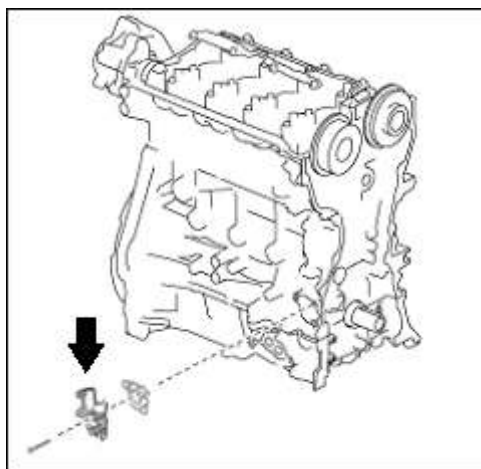
Some vehicles may have the check engine light on with DTC P0524:00 or P055F:00 stored in memory. Contamination in the engine oil may cause the engine oil solenoid valve to become stuck, resulting in improper operation of the oil pump and improper oil pressure.

- DTC P0524:00 (Engine oil pressure too low)
- DTC P055F:00 (Engine oil pressure malfunction)

The control software of the PCM has been modified to eliminate this concern. In addition, the production process has been modified to reduce contamination in the engine oil solenoid valve, oil pump, spacer and oil filter.

1. Verify the customer concern.
2. Replace the engine oil solenoid valve with a new one according to MGSS online:
  - CX-5: (ENGINE OIL SOLENOID VALVE REMOVAL/INSTALLATION [SKYACTIV-G 2.5 (WITH CYLINDER DEACTIVATION)])
  - CX-30: (ENGINE OIL SOLENOID VALVE REMOVAL/INSTALLATION [SKYACTIV-G 2.5 (WITH CYLINDER DEACTIVATION)])
  - Mazda3: (ENGINE OIL SOLENOID VALVE REMOVAL/INSTALLATION [SKYACTIV-G 2.5 (WITH CYLINDER DEACTIVATION)])
  - Mazda6: (ENGINE OIL SOLENOID VALVE REMOVAL/INSTALLATION [SKYACTIV-G 2.5 (WITH CYLINDER DEACTIVATION)])
3. Replace the engine oil and engine oil filter.
4. Reprogram the PCM / ECU with Mazda Modular Diagnostic System (M-MDS) according to:
  - 2018-2020 CX-5 and Mazda6: IDS PCM REPROGRAMMING PROCEDURE **using IDS 128.06 or later**
  - 2021 CX-5, CX-30 and Mazda3: MDARS/ECU REPROGRAMMING PROCEDURE
5. Verify the repair.
