## Check engine warning light active - fault P300CA8 and P300CA9 "Hot film mass air flow sensor malfunction" present in engine control unit

| Topic number | LI14.30-N-075882 |
| Function group | 14.30 - Secondary air injection |
| Validity | Model 907 with engine 654 |

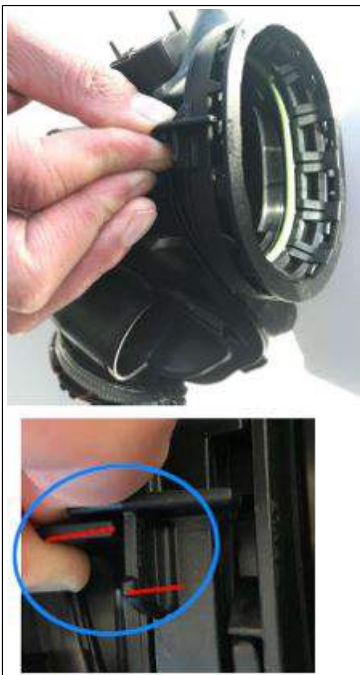
| Attachments | |
|---|---|
| <a href="#">2b.JPG</a> | |

- Operate connector coupling as far as end stop rib (open position). See Picture 2b.
- Hold connector coupling open until left-hand clean air line is pushed into the connector coupling as far as the end stop and lies flush all round. See Picture 2c
- Release connector coupling and actively slide it back to the closed position.
- Check correct seating of clean air line using the lock position. If the lock position is not visibly reached as in Picture 2d, the clean air line must be repositioned.

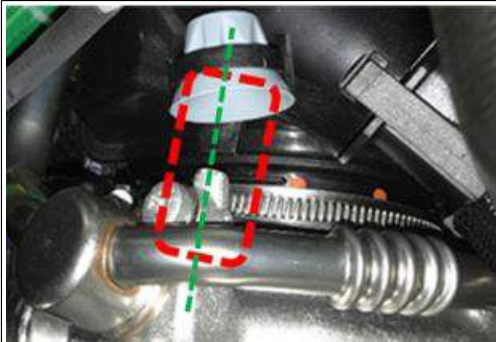
| <p>1c.JPG</p> | |

For a two-stage turbocharger, the cast lug must be cleanly aligned with the tab (see Picture 1c).

When carrying out repair and installation work, replace the seal in this area.

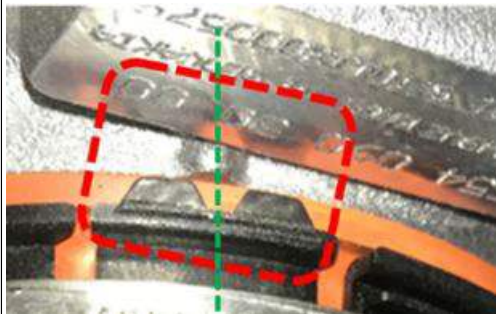
1b.JPG

For a single-stage turbocharger, the cast lug must be cleanly aligned with the counterpart profile (see Picture 1b).

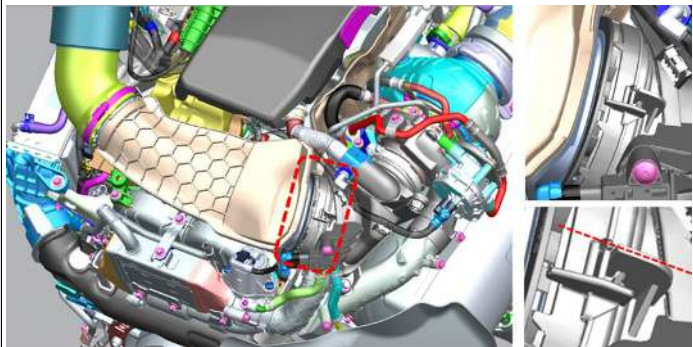
2a.JPG

Relevant area of right-hand clean air line to center clean air line (connector coupling - Picture 2a):

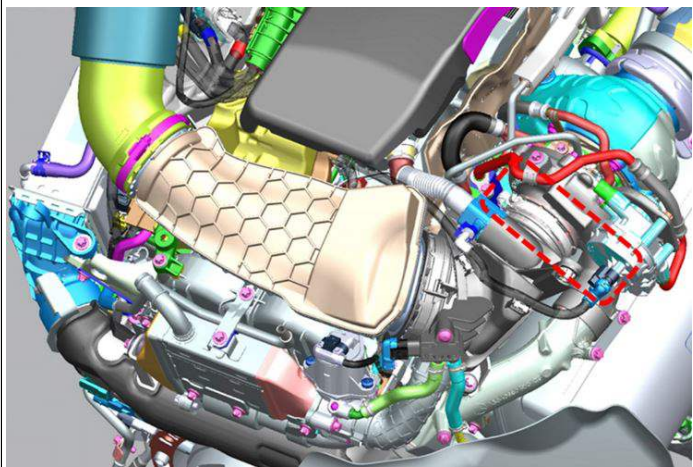
1a.JPG

Relevant area of exhaust gas turbocharger to right-hand clean air line (Picture 1a):

Check that right-hand clean air line is correctly aligned with exhaust gas turbocharger.

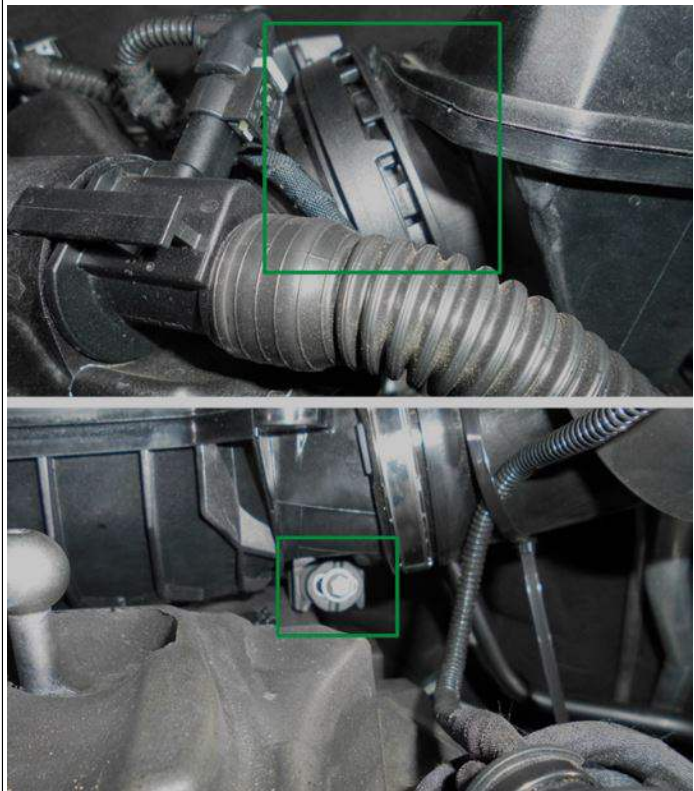
3.JPG

For example images of good and poor installation, see Picture 3 and Picture 4.
