# TECHNICAL SERVICE BULLETIN

## 4WD - Illuminated MIL With DTC U2002 - Built On 17-Nov-2022 And Through 28-Nov-2022

**23-2055**

| <b>Ford</b><br>2022-2023 F-150 | Built on 17-Nov-2022 and through 28-Nov-2022 |

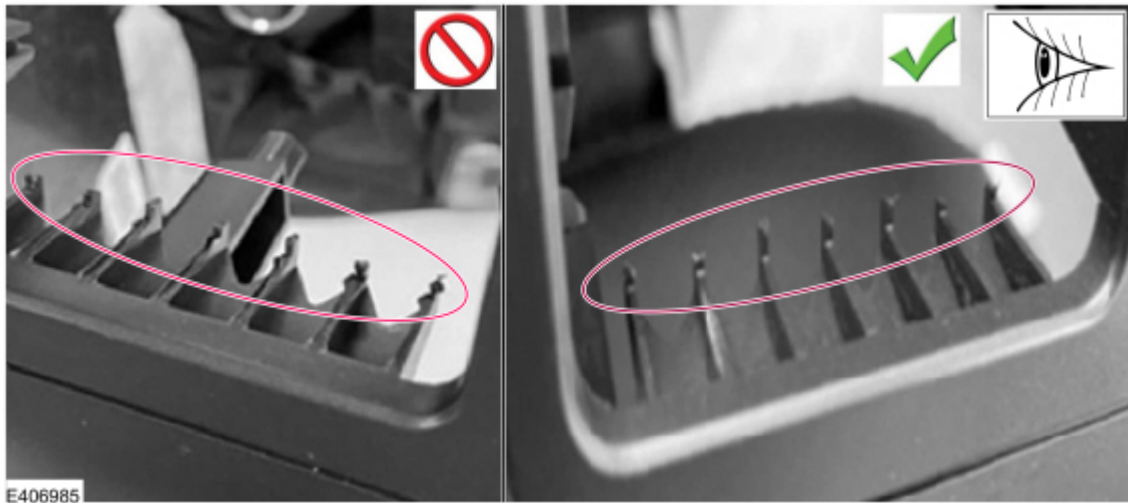
Figure 1

1. Remove the ATCM and inspect the right side of the lower centerstack trim panel where the ATCM mounts for excess material contacting the 4x4 switch (Figure 1). Refer to Workshop Manual (WSM) Section 307-07A, All Terrain Control Module (ATCM) - Vehicles Without: Center Console, Steps 1-8 for ATCM removal.

**2. Is excess material present**

**4. Replace the lower centerstack trim panel.**
