# MIL ON With DTC P060694

**Service Category** Vehicle Interior

| YEAR(S) | MODEL(S) | ADDITIONAL INFORMATION |
|---|---|---|
| 2021 - 2023 | Sienna HV | WMI(s): 5TD<br>Transmission(s): eCVT<br>Plant Code(s): S |

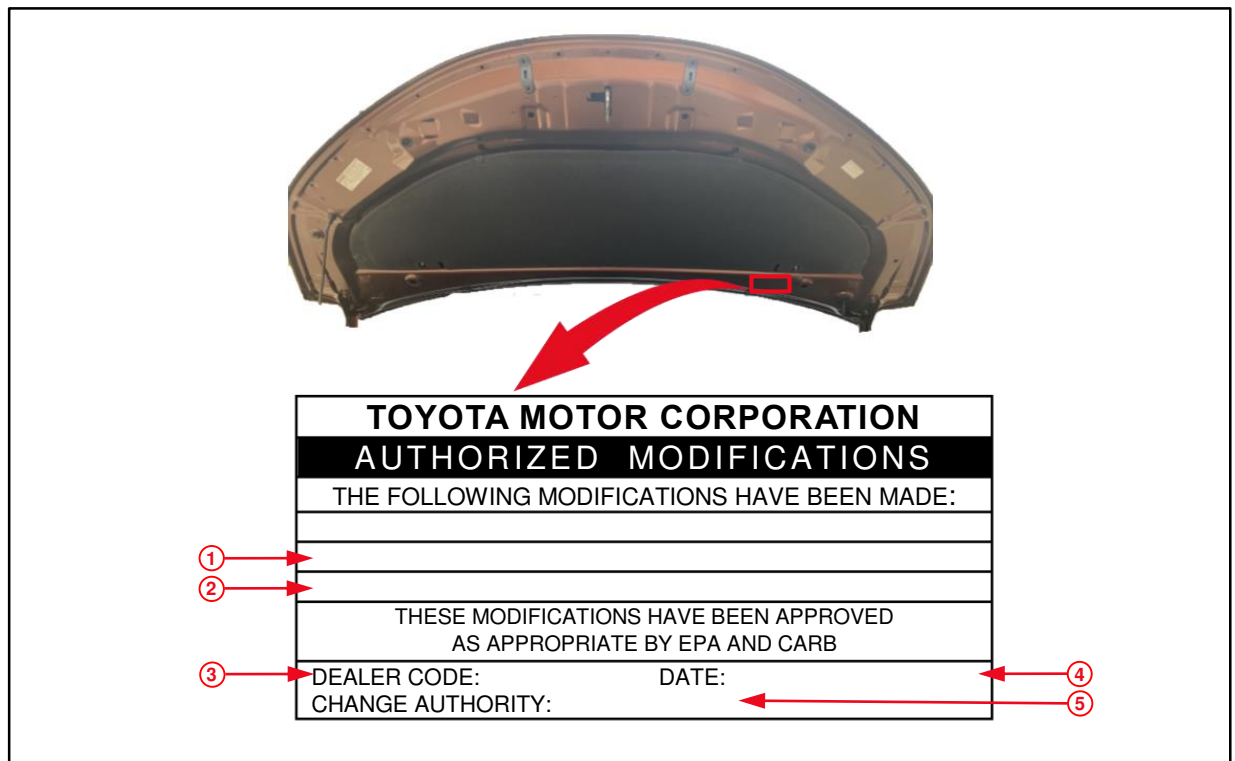
**Figure 1. Location of Authorized Modifications Label on 2021 – 2023 Sienna Hybrid**

2. Use Techstream to confirm if the hybrid vehicle control computer calibration has been updated and check for the Authorized Modifications Label affixed to the vehicle in the location shown below.

4. Prepare and install the Authorized Modifications Label.
  - A. Using a permanent marker, enter the following information on the label:
    - Hybrid vehicle control computer part number [*Refer to the **Parts Information** section for the **NEW PART NUMBER***]
    - Calibration ID(s) [*Refer to the **Calibration Information** section for the **NEW CALIBRATION ID***]
    - Dealer Code
    - Repair Date
    - Change Authority [***This bulletin number***]
  - B. Install the Authorized Modifications Label onto the vehicle at the location shown in Figure 1. The Authorized Modifications Label is available through the MDC, P/N 00451-00001-LBL (USA) or 00451-00002-MEX (Mexico).
5. Test-drive the vehicle to confirm normal operation and the condition is no longer present.
