# Technical Service Bulletin

## 27 48V Vehicle electrical system warning, DTC P0CA700 and/or U046900 stored in the starter/generator control module/ECM

27 23 55 2058831/8 May 8, 2023. Supersedes Technical Service Bulletin Group 27 number 23-51 dated March 30, 2023, for reasons listed below.

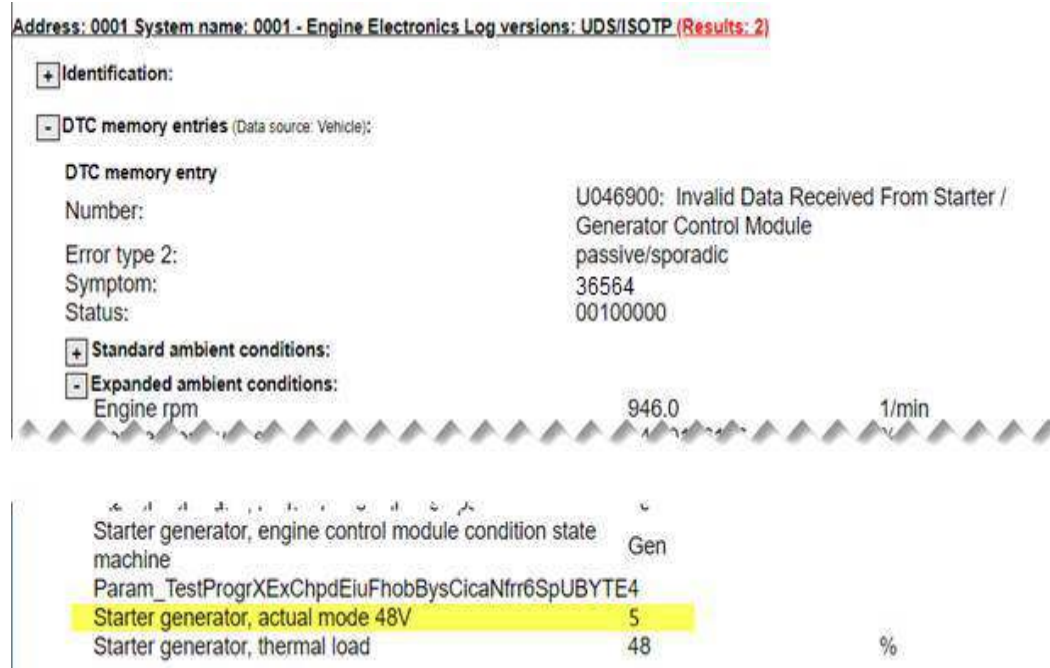
If the value displayed for *Starter generator, actual mode 48V* is not shown, or a value other than 5 is displayed (see Figure 1) please check the software version of the BSG (address word 00CC).

Figure 1: Extended ambient data in ODIS GFF log.

If the software is older than, but not including SW 0527, please update the BSG via the SVM update instructions at the end of this TSB, then follow up with the checks listed under Criterion 2.
