## STAR ONLINE PUBLICATION

**Case Number:** S2008000132 - Rev. D

**Symptom/Vehicle Issue:** Malfunction Indicator Lamp Illuminated. U11E9 Lost Communication With AGS. Ambient Air Temp Incorrectly Displayed. P0070 And P0073 Set For Ambient Air Temp Sensor

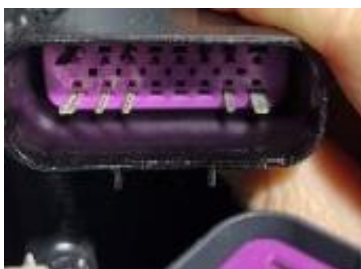
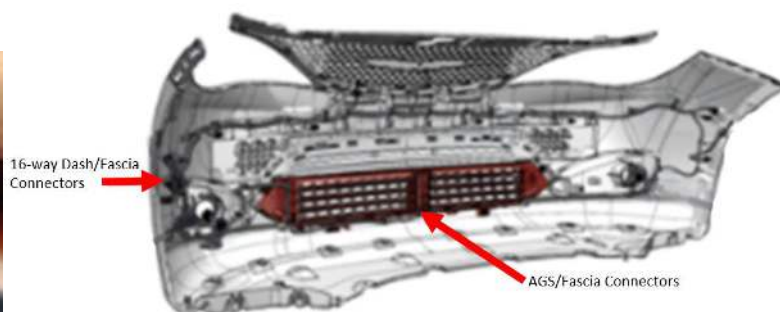
1. Inspect the wiring near the 16-way XY101A Dash to Fascia Connector for nicks and cuts. Also disconnect the connector and inspect for corrosion and terminal pushout.

1. If corrosion, damage, or terminal pushout is present at the XY101A connector. Use connector kit 68497543AA to repair the 16-way Dash side connector and replace the Fascia side harness. A connector repair kit 68500834AA for the fascia side connector is also available. But due to the various possible issues described, fascia harness replacement is recommended.

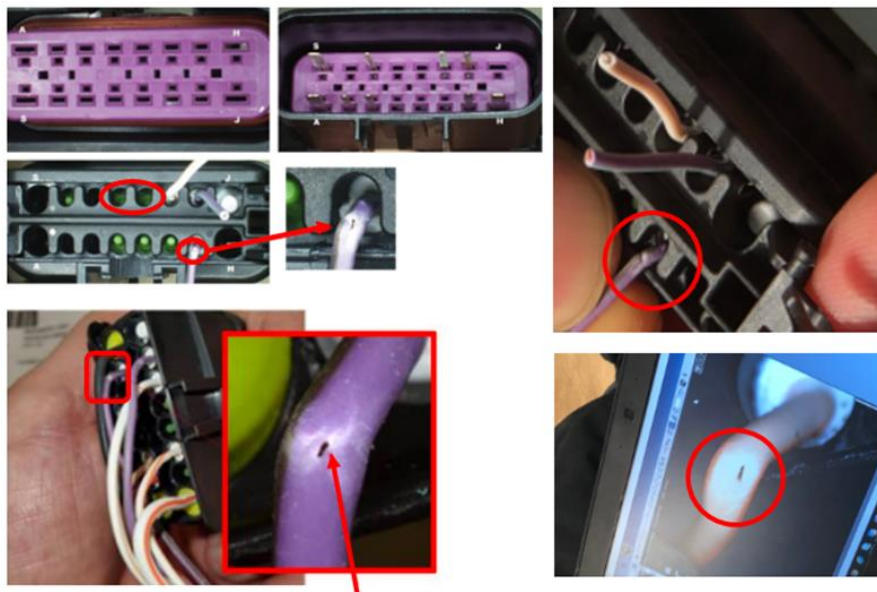
**16-Way XY101A Inline Connector Damage**

If multiple issues are found with either harness. The harnesses should be replaced instead of attempting to repair.

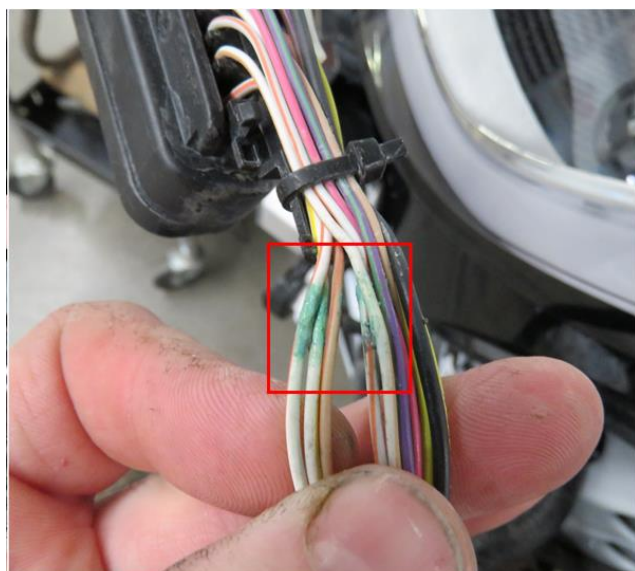
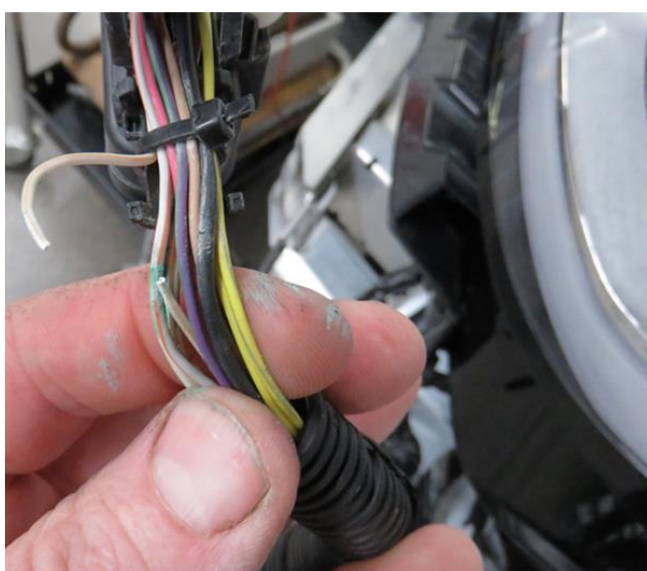
**Corroded/Damaged Harness Near 16-Way Connector**

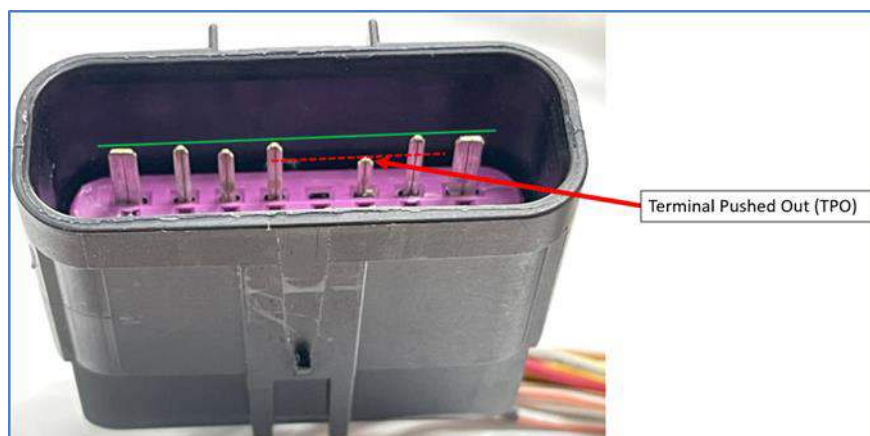
**Terminal Pushout on Inline Connector**

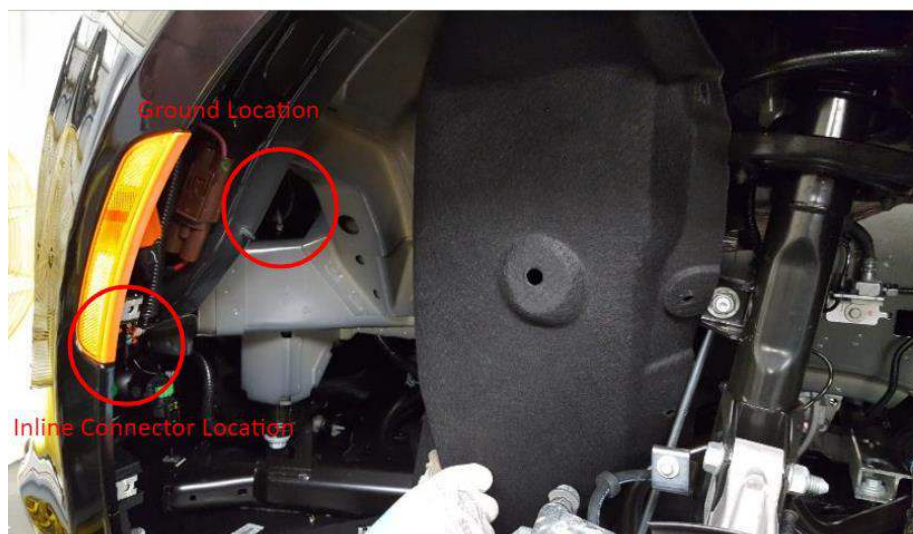
**Ground and Inline Locations**

2. The G917 ground located under the battery may be corroded creating high resistance. Water intrusion from the dash side connector could migrate to the ground, gather, and cause corrosion behind the sealed ground eyelet.

2. If the G917 ground is corroded and high resistance is measured. The ground circuit should be repaired using best practices.
3. If corrosion is present in the AGS connector, replace the AGS. **Do not add dielectric grease to the AGS/fascia connectors.** If corrosion is present in the fascia connector, repair it using connector kit 68396618AB or replace the harness as necessary.
4. If water intrusion is found in either of the Fog or Front Side Marker Lamp housings, replace the Fog and/or Side Marker assemblies. If water intrusion is found in any of the connectors. Use wiring diagrams or Mopar connector repair website to locate the correct connector repair kit (varies by model year).

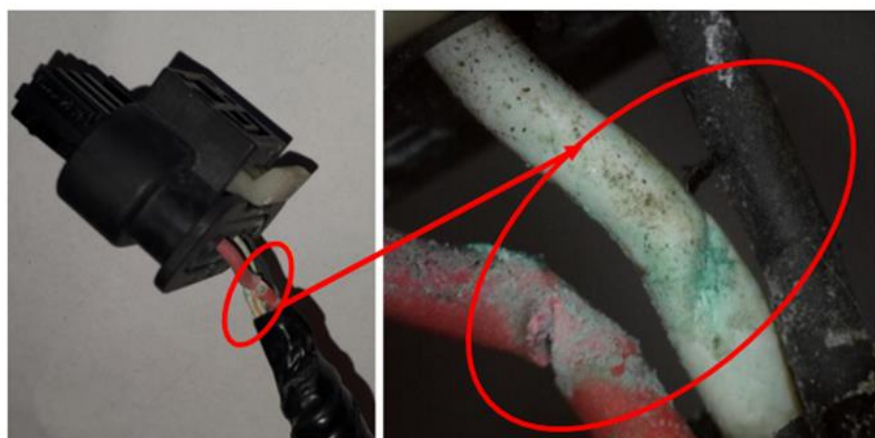
3. Disconnect the AGS to fascia/dash connectors and inspect for damage and corrosion.

### Active Grill Shutter Connection Damage/Corrosion

**Note:** If the corrosion or damage is found on the wiring harness, do not replace the mating connector on the AGS side. Repair wiring and retest.
