## Technical Service Bulletin (TSB)

### Hood Ajar Switch Inoperative

| REFERENCE: | TSB: 08-097-23<br>GROUP 08 - Electrical | Date: | April 14, 2023 | REVISION: | 08-186-22 |
| VEHICLES AFFECTED: | 2022 - **2023** (WS) Grand Wagoneer/Wagoneer<br>This bulletin applies to vehicles built on or after May 27, 2022 (MDH 0527XX) and built on or before **January 27, 2023 (MDH 0127XX).** | | | MARKET APPLICABILITY:<br><div><input checked="" type="checkbox"/> NA<input checked="" type="checkbox"/> MEA</div> <div><input checked="" type="checkbox"/> SA<input checked="" type="checkbox"/> IAP</div> <div><input checked="" type="checkbox"/> EE<input type="checkbox"/> CH</div> | |

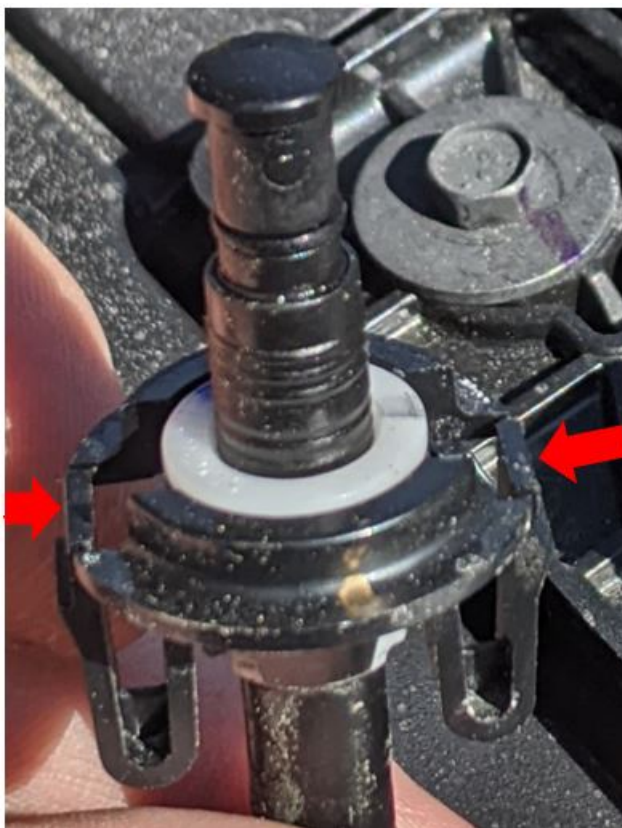
**Fig. 1**  
**Plunger Style Switch**

| CAUSE: | Hood Ajar Switch (Plunger Switch) | | | | |

1. Remove and replace the hood ajar switch. Refer to the detailed procedures available in DealerCONNECT > Service Library> under: 08 - Electrical / 8Q - Vehicle Theft Security / Switch, Hood Ajar / Removal and Installation> Plunger (Fig. 1) .
