## Technical Service Bulletin (TSB) Diesel Exhaust Fluid (DEF) Fluid Freezing

| REFERENCE: | TSB: 14-003-23<br>GROUP 14 -<br>Fuel System | Date: | April 15, 2023 | REVISION: | - |

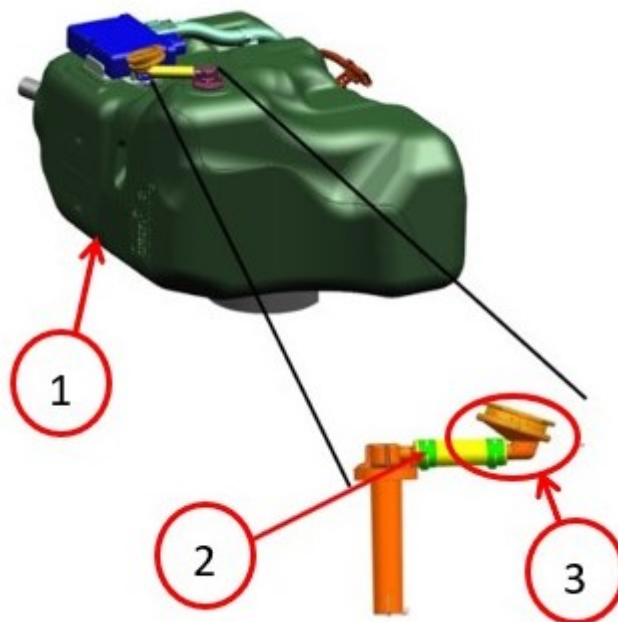
**Fig. 1**  
**DEF Tank Assembly**

- 1 - DEF Tank
  - 2 - Hose Clamp
  - 3 - Grade Vent Valve (GVV)
-

1. Remove the DEF tank. Refer to the detailed service procedures available in DealerCONNECT> Service Library under: Service Info> 25 - Emissions Control / Diesel Exhaust Fluid Emissions / Tank, Diesel Exhaust Fluid / Removal (Fig. 1) .

2. Loosen the hose clamp on the GVV hose and remove the GVV from the DEF tank.
3. Remove and replace the DEF Tank Grade Vent Valve with the new GVV (Fig. 2) .
