## Technical Service Bulletin (TSB)

### Hood Ajar Switch Inoperative

| REFERENCE: | TSB: 08-098-23 REV. A<br>GROUP 08 - Electrical | Date: | April 18, 2023 | REVISION: | 08-098-23 |
| VEHICLES AFFECTED: | 2022 - 2023 (WL) Jeep Grand Cherokee<br>This bulletin applies to vehicles built on or after May 27, 2022 (MDH 0527XX) and built on or before December 20, 2022 (MDH 1220XX). | | | MARKET APPLICABILITY:<br><input checked="" type="checkbox"/> NA<br><input checked="" type="checkbox"/> SA<br><input checked="" type="checkbox"/> EE<br><input checked="" type="checkbox"/> MEA<br><input checked="" type="checkbox"/> IAP<br><input type="checkbox"/> CH | |

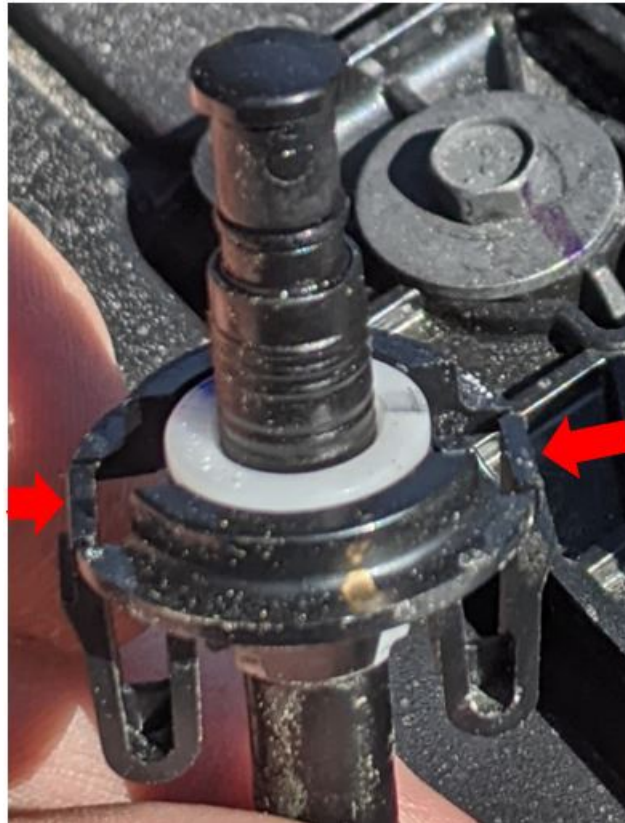
**Fig. 1**  
**Plunger Style Switch**

| CUSTOMER SYMPTOM: | The customer may experience a Malfunction Indicator Lamp (MIL) illumination. Upon further investigation the technician may find the following Diagnostic Trouble Code (DTC): <ul style="list-style-type: none"><li>• P152E - Engine Hood Switch 2 Circuit High.</li></ul> Customer may also experience the following: <ul style="list-style-type: none"><li>• Start/Stop system warning light.</li><li>• Start/Stop inoperable.</li><li>• Remote start inoperable.</li></ul> | | | | |
| CAUSE: | Hood Ajar Switch (Plunger Switch) | | | | |

1. Remove and replace the hood ajar switch. Refer to the detailed procedures available in DealerCONNECT > Service Library> under: 08 - Electrical / 8Q - Vehicle Theft Security / Switch, Hood Ajar / Removal and Installation> Plunger (Fig. 1) .
