## Technical Service Bulletin (TSB)

### Radio T25.50 USB Software Update

This bulletin involves inspecting the software level and updating the software to T25.50 if required.

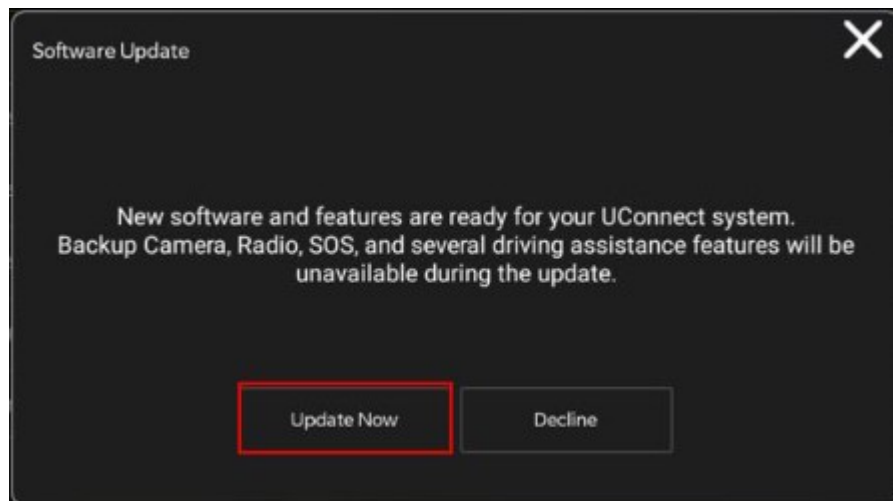
Fig. 2  
Software Update Is Available

13. Once the system has verified there is an available update, press the “Update Now” button. Make sure the vehicle is in park. **Do NOT turn the ignition off until the two minute timer has expired. The ignition doesn’t have to be turned off to update the radio’s software** (Fig. 2) .

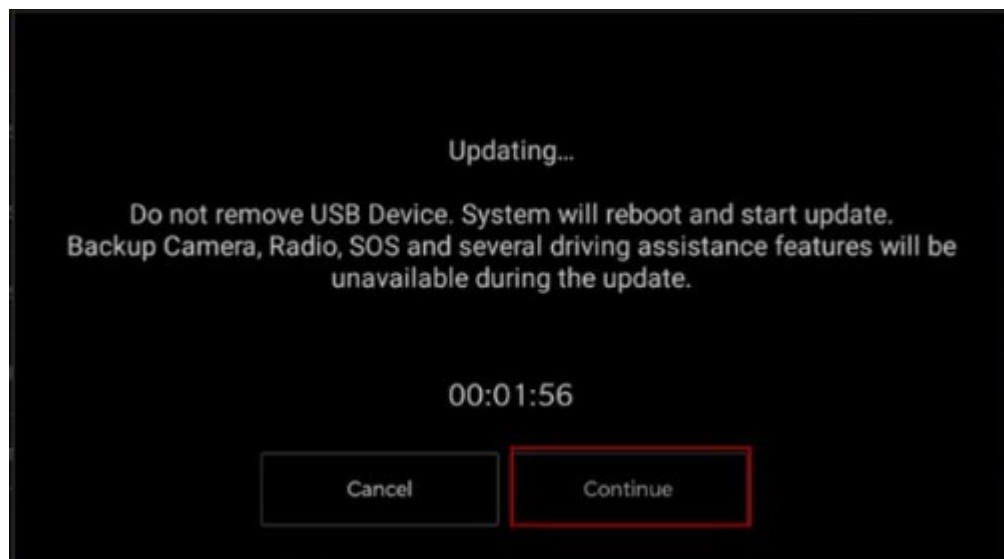
Fig. 3  
Continue Display Screen

14. Press the “Continue” on the display screen (Fig. 3) .

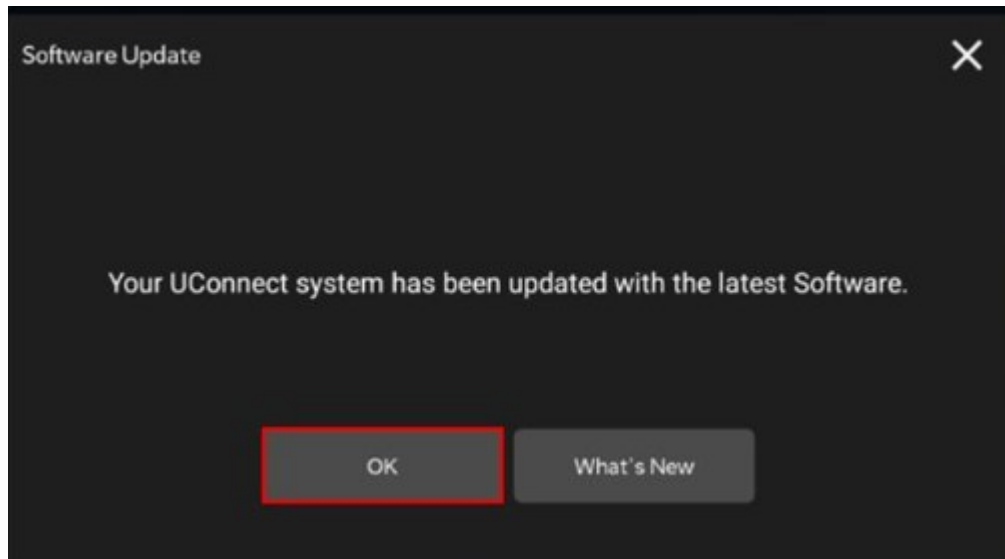
**Fig. 6**  
**Radio Software Has Been Updated**

18. Press “OK” to continue (Fig. 6) .
