## Technical product information

| <b>Topic</b> | DTC B17B801 and/or B17B804 - evident within address 0019 and/or DTC U112300 evident in 00A5 |
| <b>Brand</b> | Bentley |
| <b>Transaction No.</b> | 2063855/8 |

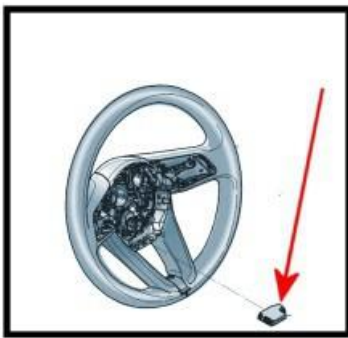
Lane Assist and/or Traffic Assist are not functional

- DTC - B17B801 - Steering Wheel Touch Recognition Control Module evident within **address 0019**

- DTC B17B804 - Steering Wheel Touch Recognition Control Module electrical error - evident within **address 0019**

- DTC U112300 with symptom Code 1123220 within **address 00A5**

- 1) Referring to Rep.Gr 69 - Remove the driver's air bag
- 2) Referring to Figure 1 - Fit a Control Unit for Steering Wheel Contact Detection control unit (J1158) to the new steering wheel
