| <b>Topic</b> | Bentayga - Fuel Gauge - Guided Fault Finding DTC's B103E1B and/or B10581B evident within address 0046 |
| <b>Brand</b> | Bentley |
| <b>Transaction No.</b> | 2060081/3 |

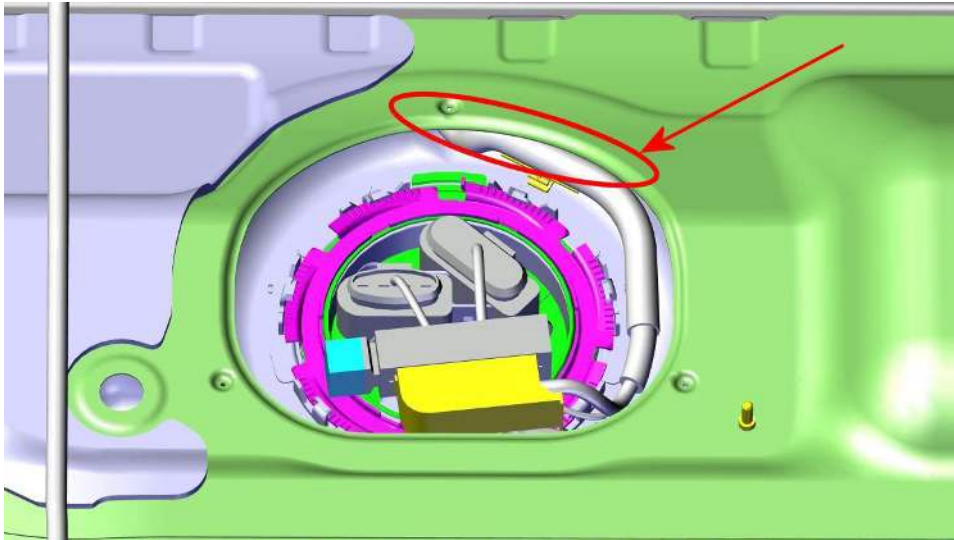
- Referring to Figure 5 – Conduct a check of the wiring harness to confirm if any damage is evident

**Should any issues be found regarding wiring harness damage – The operative must raise a new DISS query or update the already existing query ensuring photographs of the issue and a description of the damage is included**
