May 19, 2023

Version 1

## Accord CAN Gateway Errors DTC U1803-88 and Code TT06

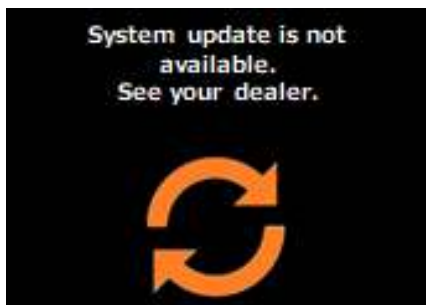
In all trims, the message below appears in the Meter. When i-HDS is used to perform an **ALL DTC Scan**, the DTC U1803-88 will be returned.

A software issue is causing an internal Ethernet error in the CAN Gateway Unit (CGW).

Restart the Over the Air (OTA) System, then update the CGW to the latest software version.

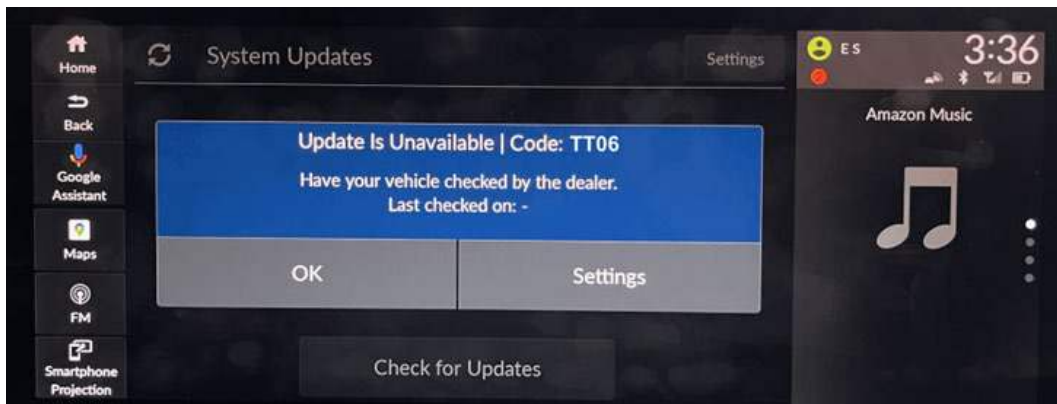
In Hybrid trims, the audio unit may also display Code TT06.
