June 2, 2023

## Accord CAN Gateway Errors DTC B2B05-92 and Code K201

Supersedes 23-045, dated May 23, 2023, to revise the information highlighted in **yellow**.

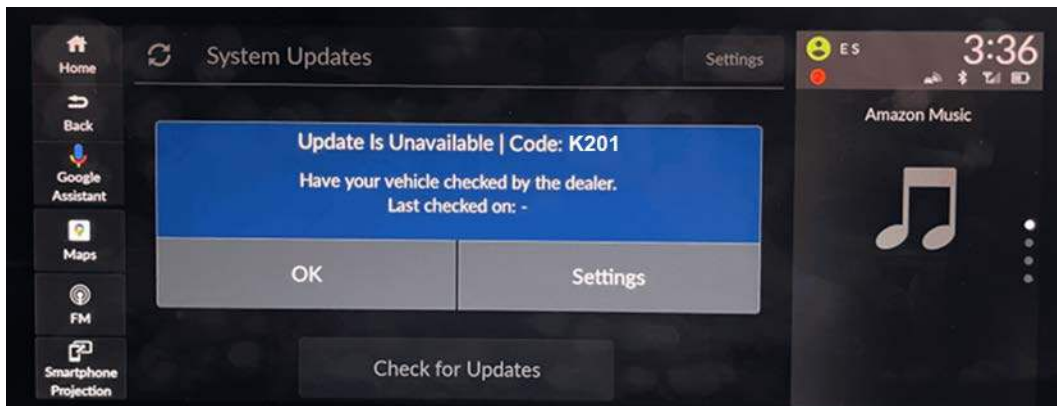
In Hybrid trims, the audio unit may also display Code K201.

A software issue in the Telematics unit causing the error to occur. Under certain conditions, if the Power Mode is set to Off while a software update is preparing for installation, the DTC and Code can appear.

Restart the OTA System, then update the Telematics unit to the latest software version. If the software is up to date, and the DTC returns, follow the trouble shooting steps for DTC B2B05-92.
