## QUALITY ACTION

## CAMPAIGN BULLETIN

### Fan Coupling Nut Torque Inspection

Reference: P3A05

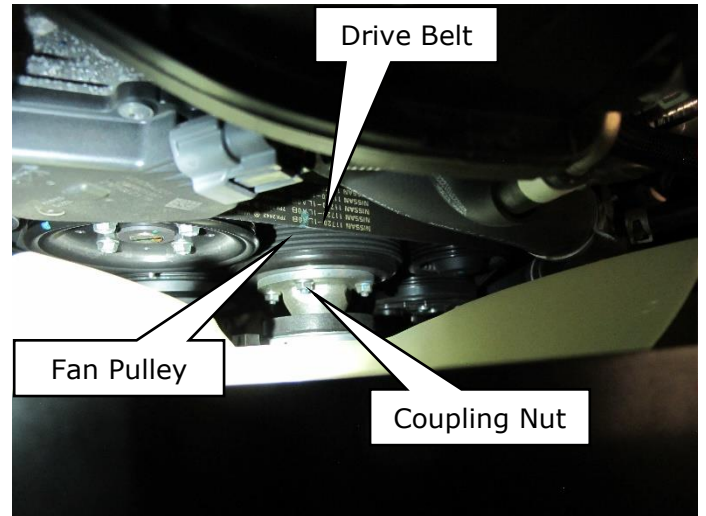
Figure 7

- a. Drive belt and fan pulley (Figure 7): **Must not have any damage.**
- b. Missing fan coupling nuts (Figure 7): **Must have (4) present.**
- c. Cooling fan and shroud (Figure 8): **Must not have any damage.**
- d. Radiator hoses in area of cooling fan (Figure 8): **Must not have any leaks.**
- e. Transmission fluid warmer pipes in area of cooling fan (Figure 8): **Must not have any leaks.**

- **YES =>** Provide clear photos of the damaged components found in Step to FQA using the information below. **HOLD** the vehicle until further notice.
