## CAMPAIGN BULLETIN

### Fan Coupling Nut Torque Inspection

Reference: P3A06

## P3A06 – 2023 QX80 COOLING FAN COUPLING NUTS

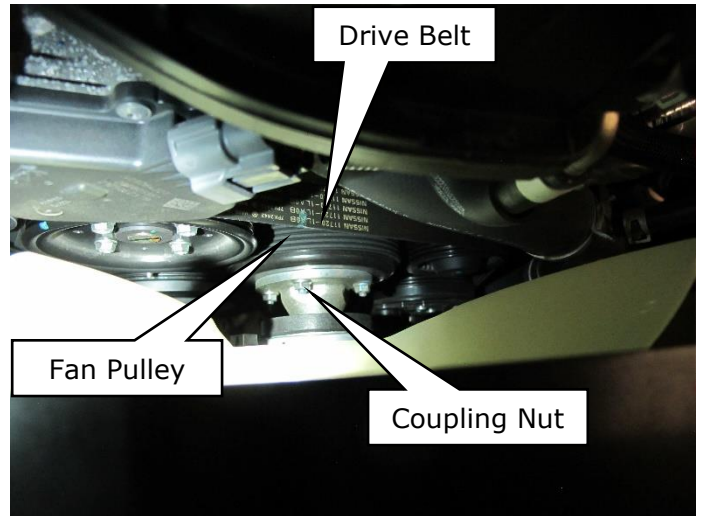
Figure 7

- a. Drive belt and fan pulley (Figure 7): **Must not have any damage.**
- b. Missing fan coupling nuts (Figure 7): **Must have (4) present.**
- c. Cooling fan and shroud (Figure 8): **Must not have any damage.**
- d. Radiator hoses in area of cooling fan (Figure 8): **Must not have any leaks.**
- e. Transmission fluid warmer pipes in area of cooling fan (Figure 8): **Must not have any leaks.**

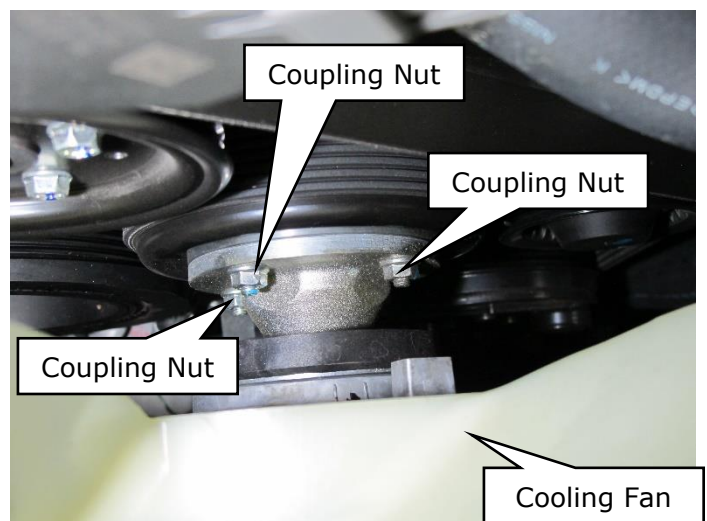
Figure 9

7. Locate the (4) fan coupling nuts.

**NOTE:** The bottom fan coupling nut is not shown in Figure 9.
