# Service Bulletin

Bulletin No.: 23-NA-062

Subject: Rear View Camera Issues – DTCs B395A, B395B, B395C, B101E, B101D

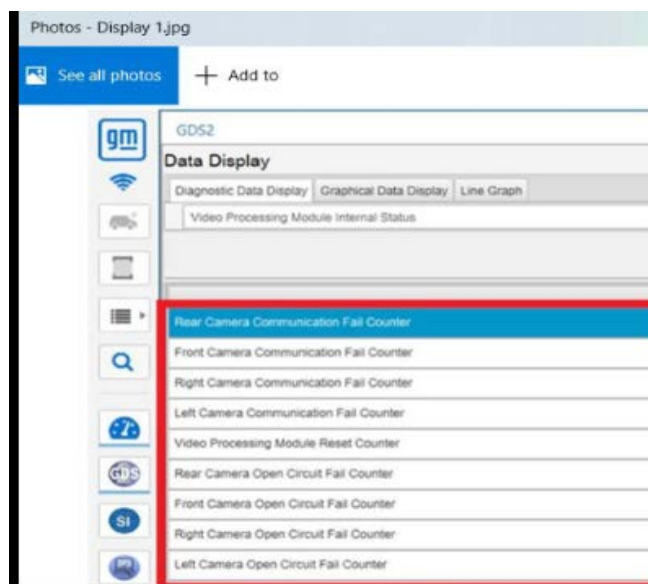
6083540

The VPM counters are listed in priority order from most usefulness to least. The ones outlined in red are considered the most critical and usually most helpful in root causing surround viewing issues.

3. The three most critical parameters to look at are:
  - 3.A. Camera Communication Fail Counter
  - 3.B. Video Processing Module Reset Counter
  - 3.C. Camera Open Circuit Counter

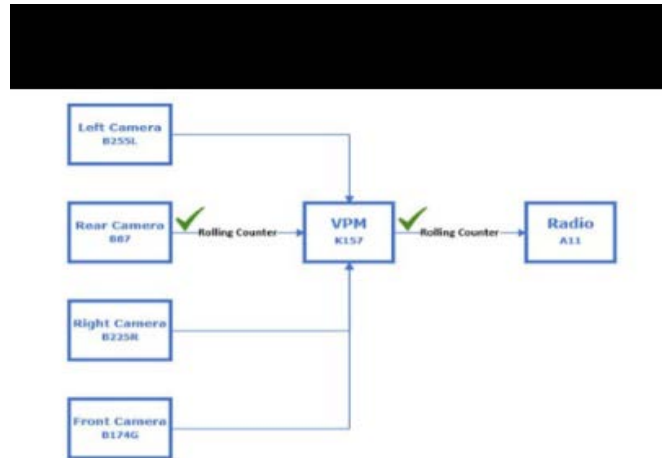
6083545

The Radio requires a rolling counter to ensure a video output on the radio screen. This counter prevents a frozen image to be displayed to the vehicle owner when shifting into Reverse.

This rolling counter is monitored continuously to ensure we have video signal from the rear camera. It goes from the rear camera to the VPM and from the VPM to the radio.

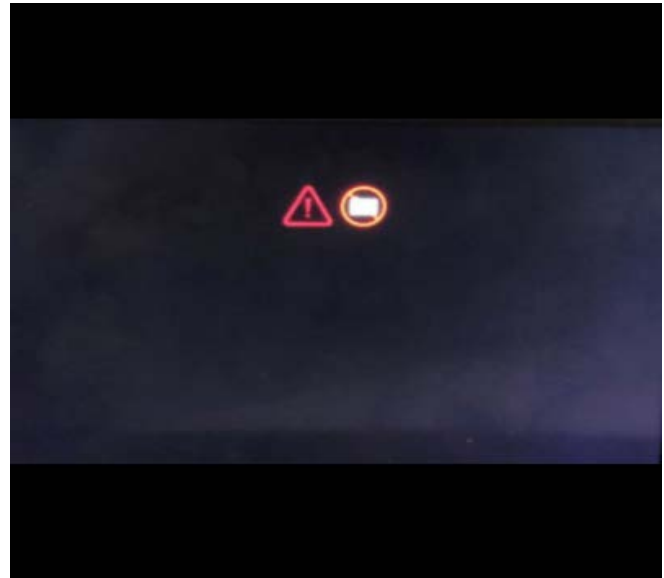
6083546

If the rear camera or the VPM do not provide the rolling counter, you will see the following black screen with an icon:

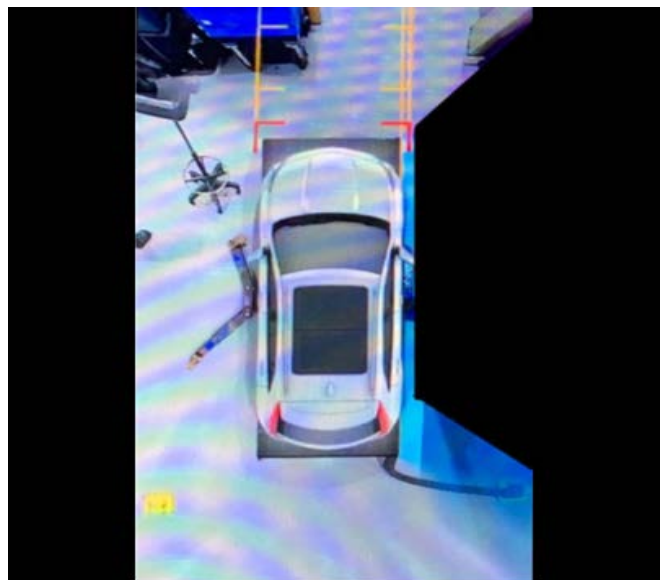
6083547

The VPM does not monitor the left, right or front cameras with a rolling counter. These camera's will display in black on their perspective side if there is an issue.

Figure below is of a right camera issue:
