# Service Bulletin

Bulletin No.: 23-NA-099

**Subject:** Black Radio Display Screen (triangle and camera with the slash through it) with DTCs B1A62 82 and 86 setting current in Video Processing Module (VPM)

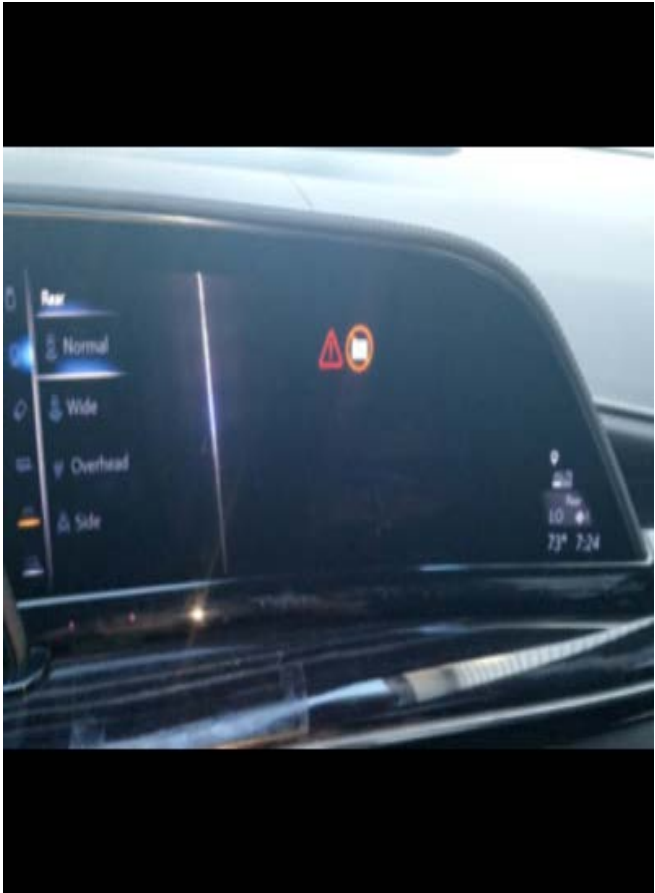
6361573

| Condition | Some customers may comment on a condition present on startup on the radio display where a black screen with a triangle and a camera with the slash through it is displayed. |

| | <p>Technicians may find two DTCs set current or in recent history:</p> <ul style="list-style-type: none"> <li>" DTC B1A62 82</li> <li>" DTC B1A62 86</li> </ul> |
| Cause | The cause of the condition may be software anomalies in the VPM. |

| Correction | Reprogram the VPM with the latest software released. |
