# Service Bulletin

Bulletin No.: 23-NA-095

**Subject:** Lane Keep Assist Unavailable / Adaptive Cruise Control Inop / Service Driver Assist Systems / Amber Front Collision Icon On / Dead Battery / No Crank / Front View Camera / Auto Start Stop Inop / Unable To Complete Camera Learn Stops At 94% /DTC U3000 44 49 54 and/or 57

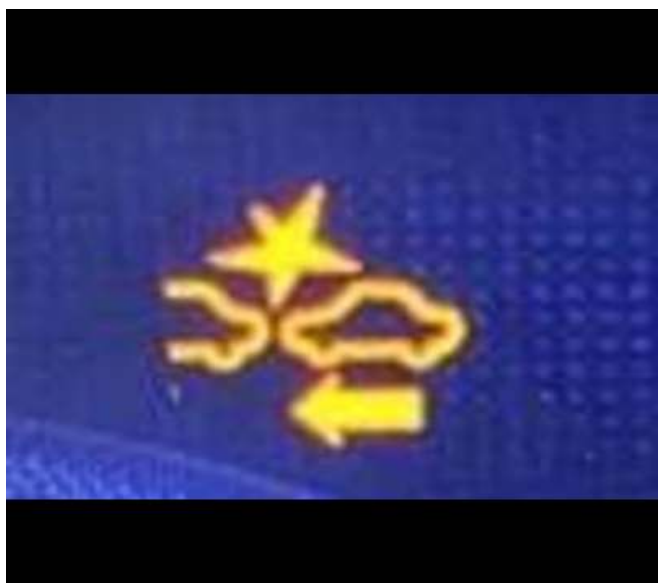
6054884

| Condition | <p>Some customers may comment on an amber Forward Collision icon displayed in the IPC, as shown below. Also, DTC U3000 symptom 44, 49, 54, and/or 57 may or may not be set current in the Front View Camera Module. In some cases, there could be a low or dead battery condition. Customers may also notice certain features related to the Front View Camera are unavailable, such as:</p> <ul style="list-style-type: none"><li>– Forward Collision Alert (RPO: UEU)</li><li>– Following Distance Indicator (RPO: UE4)</li><li>– Low Speed Collision Mitigation Braking (RPO: UHY)</li><li>– Pedestrian Collision Mitigation Braking (RPO: UKJ)</li><li>– Lane Keep Assist (RPO: UHX)</li><li>– Automatic High Beam Assist (RPO: TQ5)</li><li>– Adaptive Cruise Control (RPO: KSG)</li></ul> <p>Note: Because this condition could cause a low/dead battery, it can cause the Auto Stop/Start feature to be disabled due to the battery start of charge. The front view camera module issue should be corrected first before diagnosing an auto stop/start concern.</p> |
| Cause | The cause of the condition may be Onstar performing a task, which causes the B174W Front View Camera to set the DTC and disable during the next vehicle start up. |

1. Turn the ignition off.
2. Reprogram the Front Camera Module with the latest software in SPS. Refer to Front View Camera Module Programming and Setup in SI.

3. Clear any DTCs.
4. Check camera operation.
  - If the camera operation has returned, then no further action is required.
  - If the camera operation has NOT returned, then perform a camera relearn using GDS2.
  - If the camera will not complete the Front View Camera relearn procedure, then see Extended Camera Relearn Procedure shown below.
