# DTC U010087 & No Start/ Replaced Engine ECU After Jump Starting

A25A-FXS

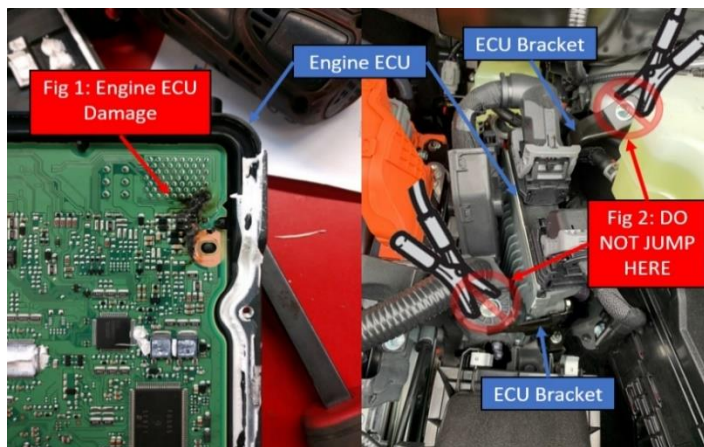
After jump-starting, the vehicle may experience a no-start condition and multiple DTCs including U010087. Upon investigation, it is found that the engine ECU has been damaged and needs to be replaced (Fig 1). In several cases, it was found that the cause of the ECU damage was improper jump starting. Further investigation found that ECU damage may occur if the jumper cables are hooked up on or around the engine ECU or ECU mounting bracket (Fig 2).
