# Technical Service Bulletin

## 90 Driver Assist Systems various improvements (DTC C12D5FA, B200FF9, B107A16, intersection assist arrows flicker)

90 23 29 2069244/2 June 12, 2023. Supersedes Technical Service Bulletin Group 90 number 23-99 dated February 2, 2023, for reasons listed below.

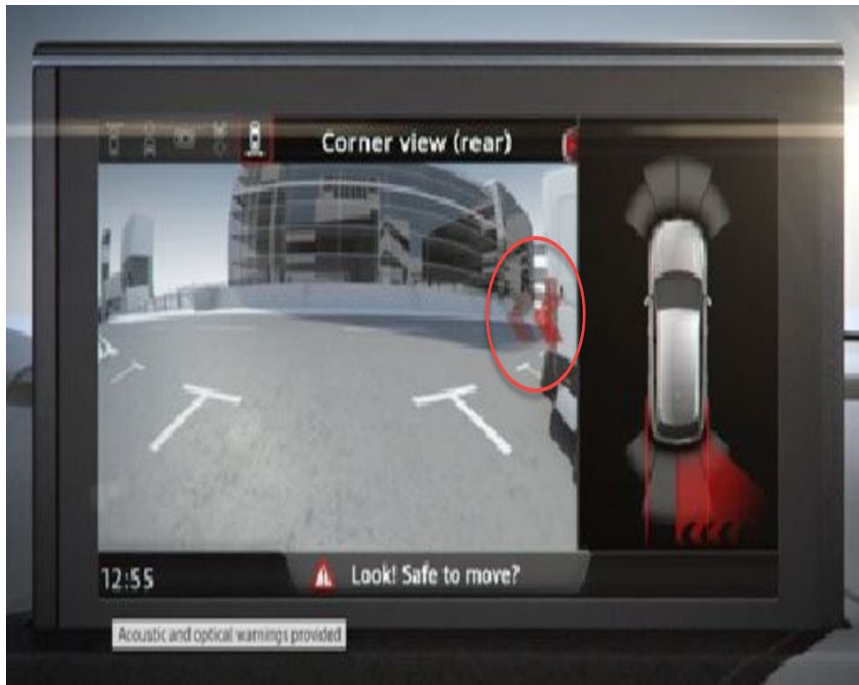
- The intersection assist arrows flicker for a short period after the vehicle has started (figure 1).

**Figure 1:** RCTA/Intersection assist arrows.

The complaints listed have been observed with prior versions of the control unit software.

The optimized software for the affected control units was implemented in production in model year 2023.

1. Follow all instructions in TSB 2011732: *00 Software Version Management (SVM), operating instructions*. The update may take, depending on the vehicle equipment and prior software level, between 30 and 90 minutes.
2. Update the vehicle using the SVM action code as listed in the table below, if necessary:
