# Technical Service Bulletin

**97 MIL on, chafing found on transmission harness, DTC's: P157600, P157200, P218100, P260200, P260000**  
97 23 95 2070557/1 June 2, 2023.

| Model(s) | Year | VIN Range | Vehicle-Specific Equipment |
|---|---|---|---|
| A6 allroad, A6, and S6 | 2023 | 043477 – 046976 | Not Applicable |

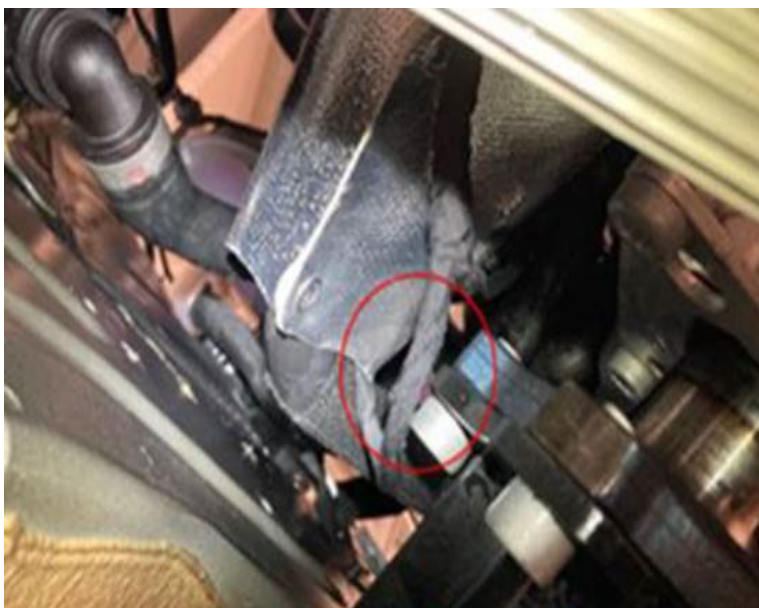
The wiring harness for the automatic gearbox is chafing on the front left drive shaft.

**Figure 1:** Transmission harness contact point.

Check the wiring on the left side of the gearbox (Figure 1).

If wiring harness damage is found, repair using wiring harness repair set **VAS 1978 B**.

Replace the harness if it is damaged beyond repair. In this case, attach a photo of the damage to DOC-IT for review.

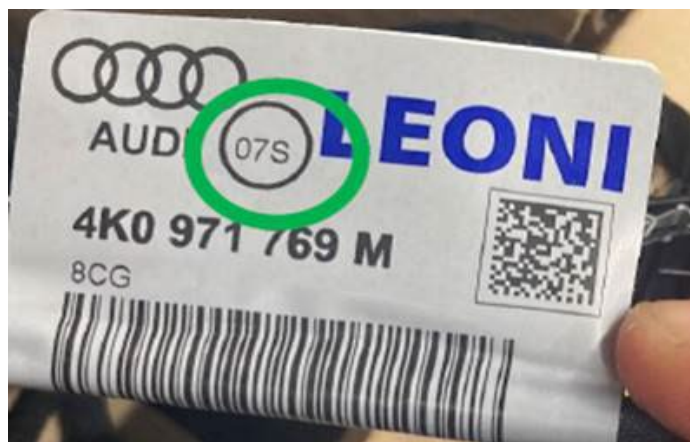
**Figure 2:** Example of 07S harness.

Regardless if harness is repaired or replaced, check the gearbox wiring harness generation (Figure 2).

Route the harness as described below depending on harness generation **06S** or **07S**.

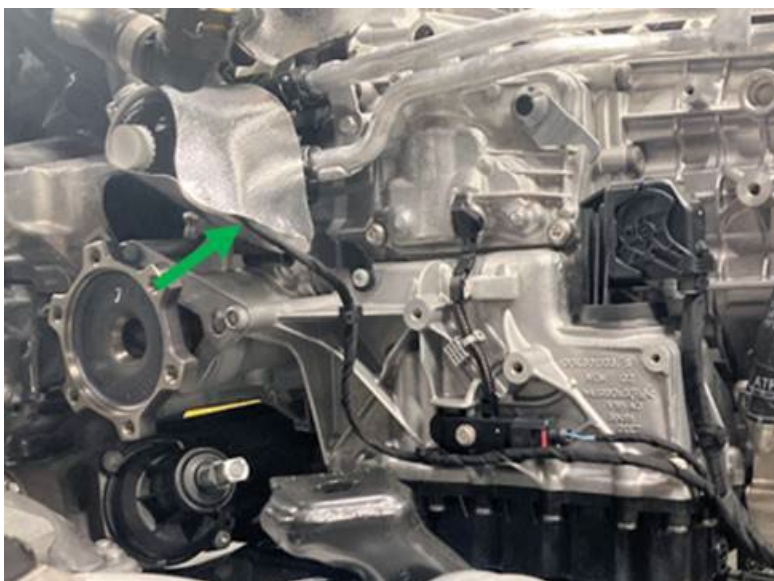
**Warning:** If this is not the performed, the wiring harness will make contact with the drive shaft again.

*Figure 3: Optimized routing for generation 06S.*

The generation 06S wiring harness **must be** routed through the circulation pump heat shield (the two buttons determine the position, green arrow, Figure 3).

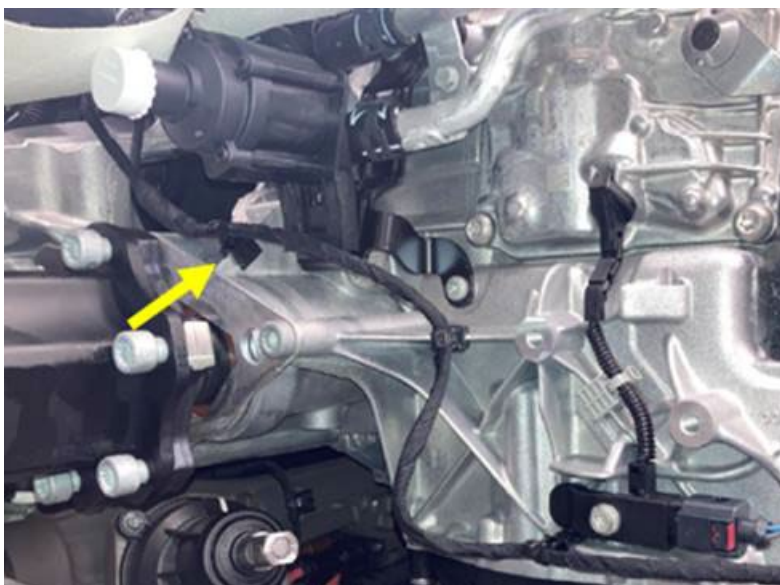
*Figure 4: Optimized routing for generation 07S.*

Generation 07S has a different shape and an additional retaining element (see yellow arrow in Figure 4). Generation 07S **must not be** routed through the circulation pump heat shield.
